CONDITION ASSESSMENT OF CANAL WALLS REPORT

North Canal
Lawrence, MA

0228526.02
City of Lawrence, MA
May 2019

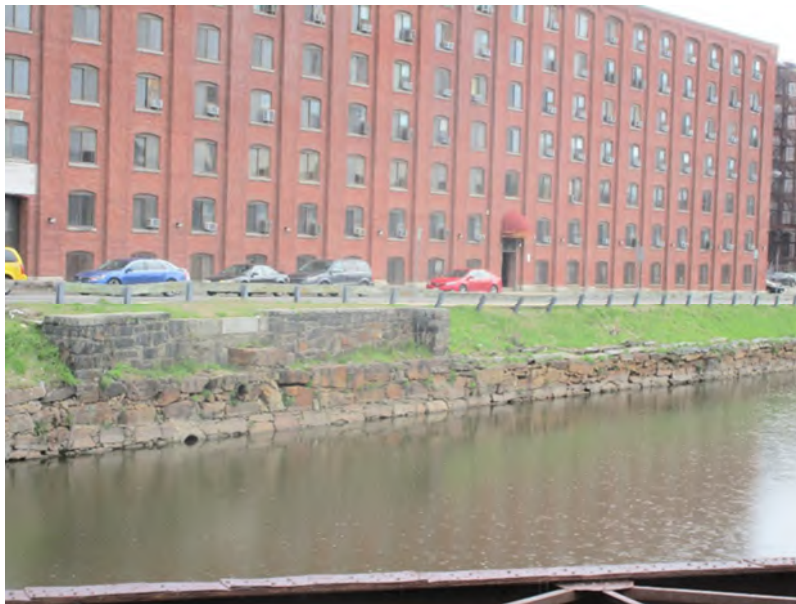
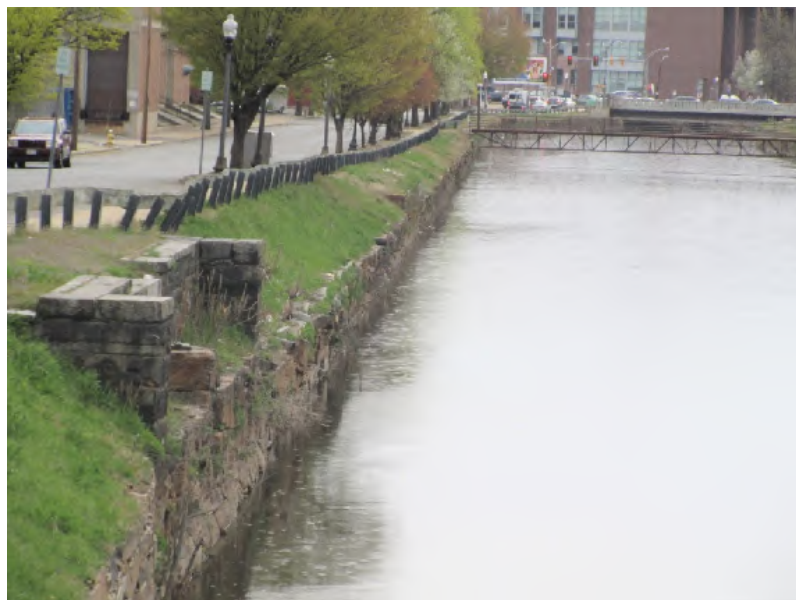
Wall Section: Item #N4; Station 1 + 90 to 3 + 80; Risk Level 2

Observations: VG (vegetation growth); top of wall uneven, potential differential settlement; appears unstable; out of plumb/top leaning into canal; large open joints and voids; missing stones; dislodged stones; overburden pushing top stones toward canal. See photos below.

Recommendations: Rebuild this wall section with stone construction to match existing.

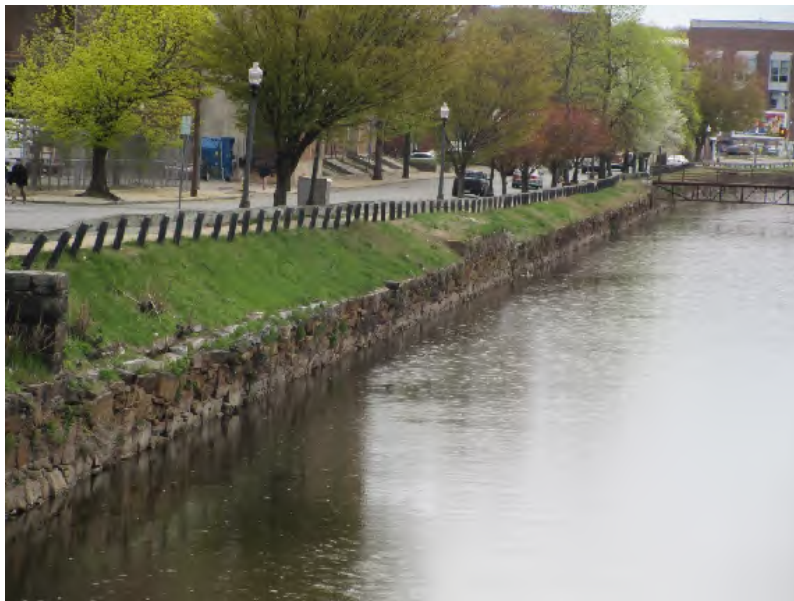
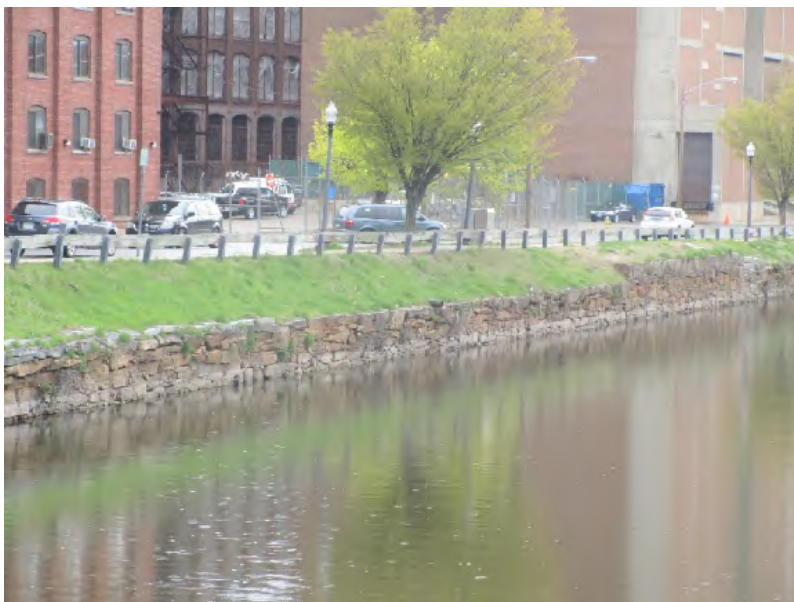
Wall Section: Item #N5; Station 3 + 80 to 5 + 30; Risk Level 1

Observations: VG; top of wall uneven, potential differential settlement; appears unstable; out of plumb/top leaning significantly into canal; bowing; bulging; irregular and variable face; large open joints and voids; missing stones; dislodged stones; overburden pushing top stones towards canal. See photos below.

Recommendations: Rebuild this wall section with stone construction to match existing.

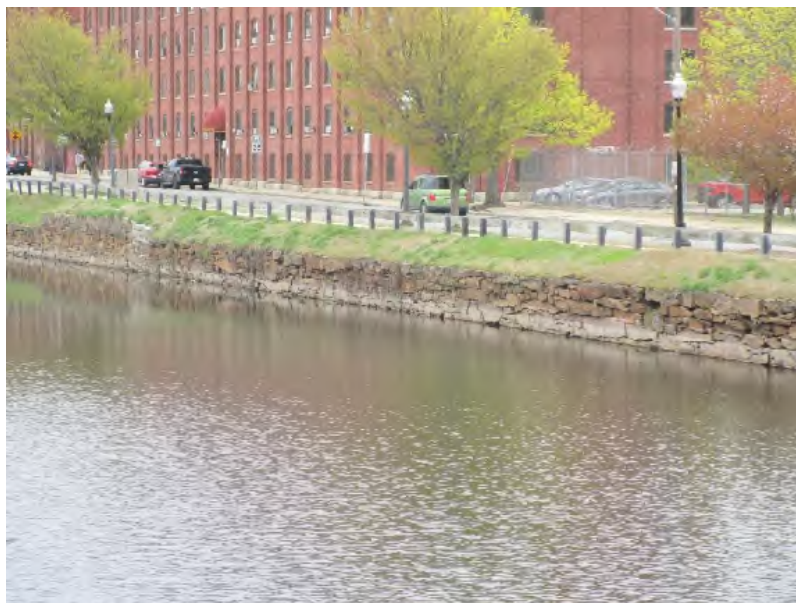
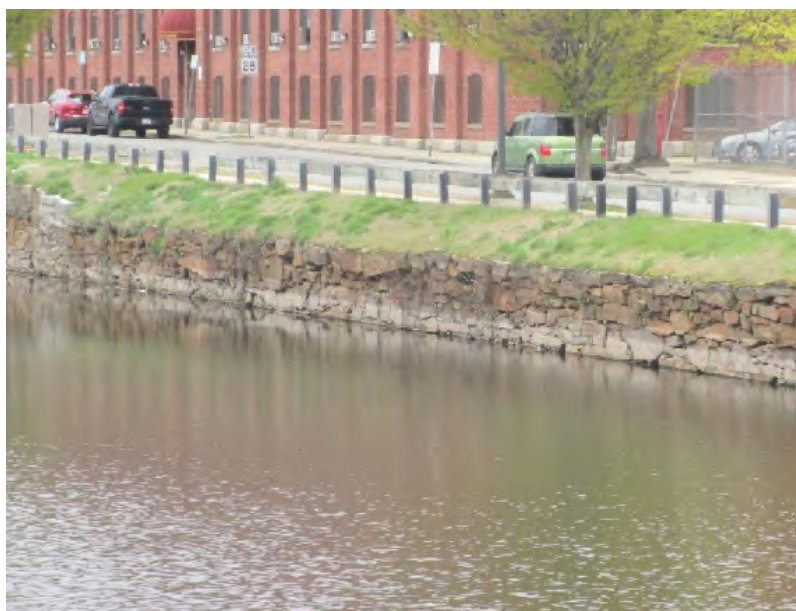
Wall Section: Item #N6; Station 5 + 30 to 6 + 95; Risk Level 1

Observations: VG; top of wall uneven, potential differential settlement; appears unstable; out of plumb/top leaning significantly into canal; bowing; bulging; irregular and variable face; large open joints and voids; missing stones; dislodged stones; overburden pushing top stones towards canal. See photos below.

Recommendations: Rebuild this wall section with stone construction to match existing.

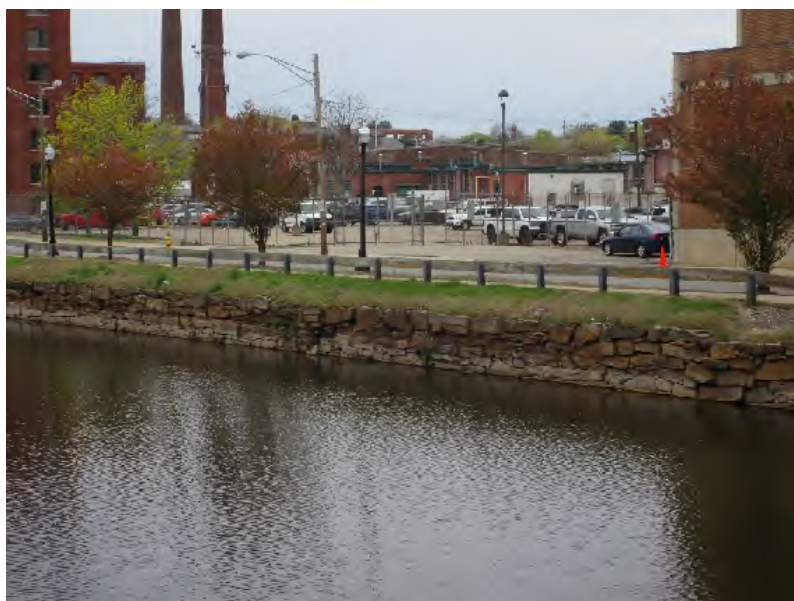
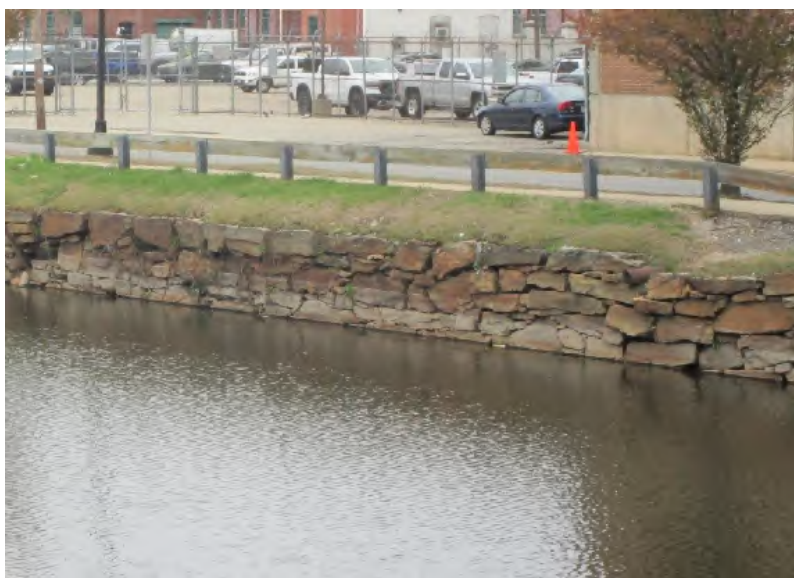
Wall Section: Item #N7; Station 6 + 95 to 8 + 05; Risk Level 1

Observations: VG; top of wall uneven, potential differential settlement; appears unstable; out of plumb/top leaning significantly into canal; bowing; bulging; irregular and variable face; large open joints and voids; missing stones; dislodged stones; overburden pushing top stones towards canal. See photos below.

Recommendations: Rebuild this wall section with stone construction to match existing.

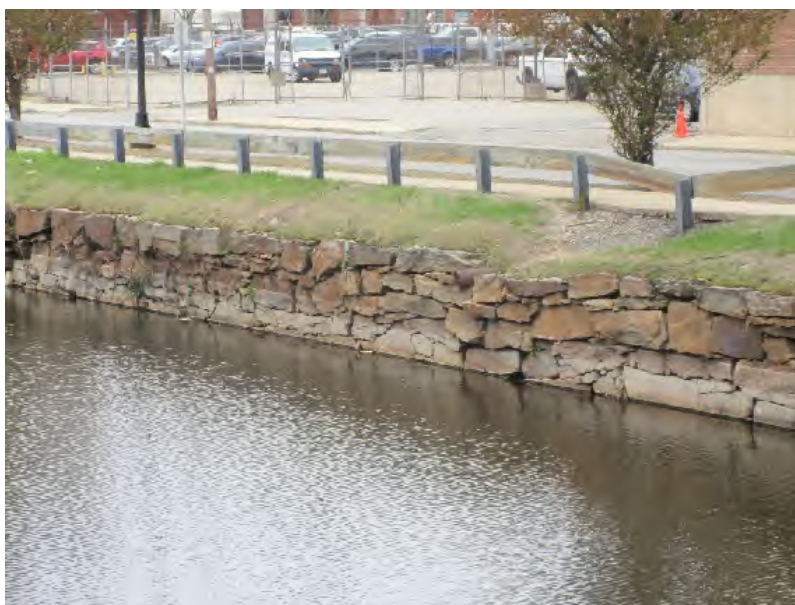
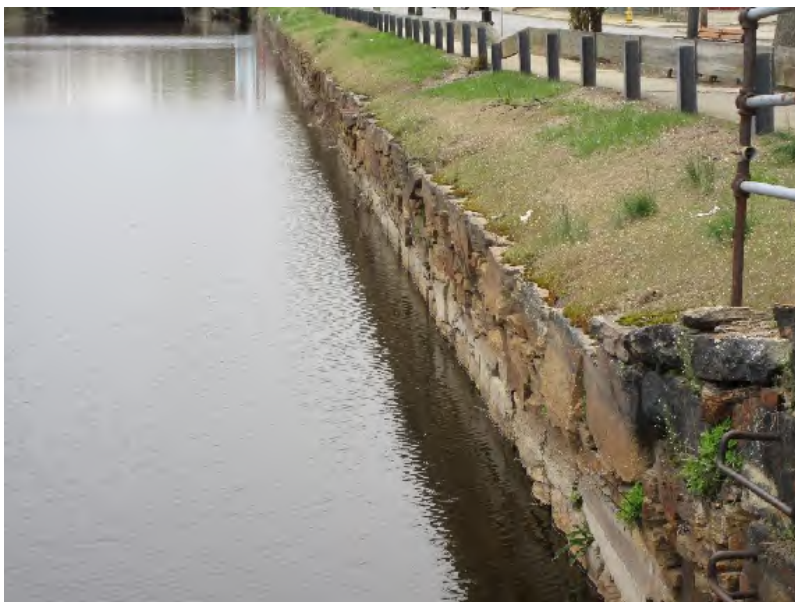
Wall Section: Item #N8; Station 8 + 05 to 9 + 95; Risk Level 1

Observations: VG; top of wall uneven, potential differential settlement; appears unstable; out of plumb/top leaning significantly into canal; bowing; bulging; irregular and variable face; large open joints and voids; missing stones; dislodged stones; overburden pushing top stones towards canal. See photos below.

Recommendations: Rebuild this wall section with stone construction to match existing.

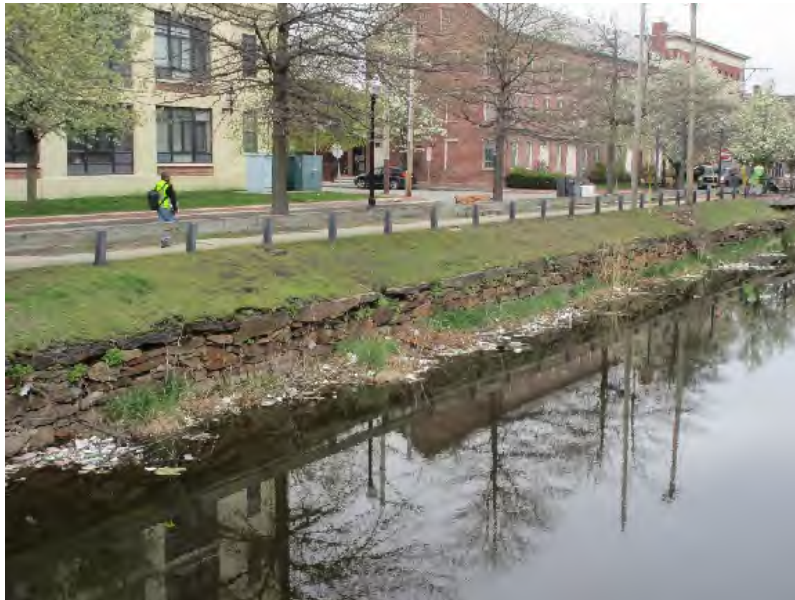
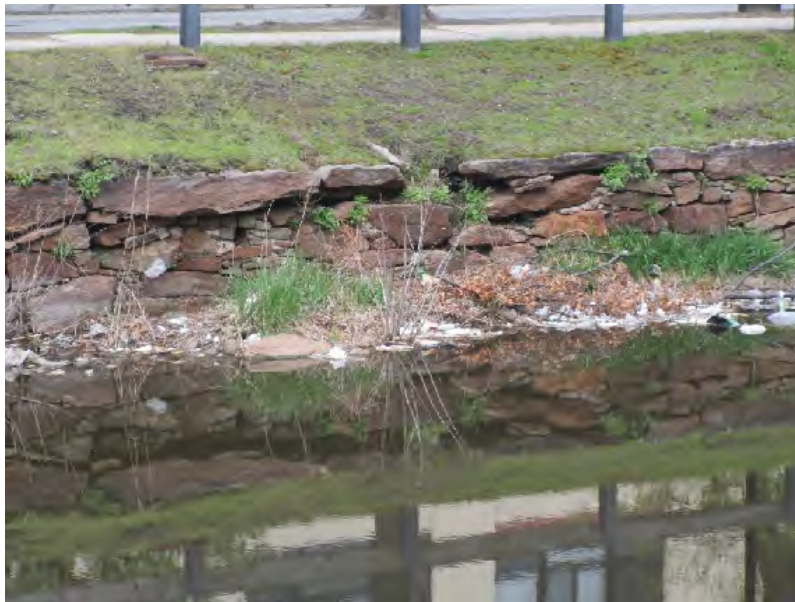
Wall Section: Item #N17; Station 26 + 30 to 28 + 40; Risk Level 2

Observations: Heavy VG; out-of-plumb, leaning toward canal; appears unstable; major open joints and voids; dislodged stones. See photos below.

Recommendations: Rebuild this wall section with stone construction to match existing.

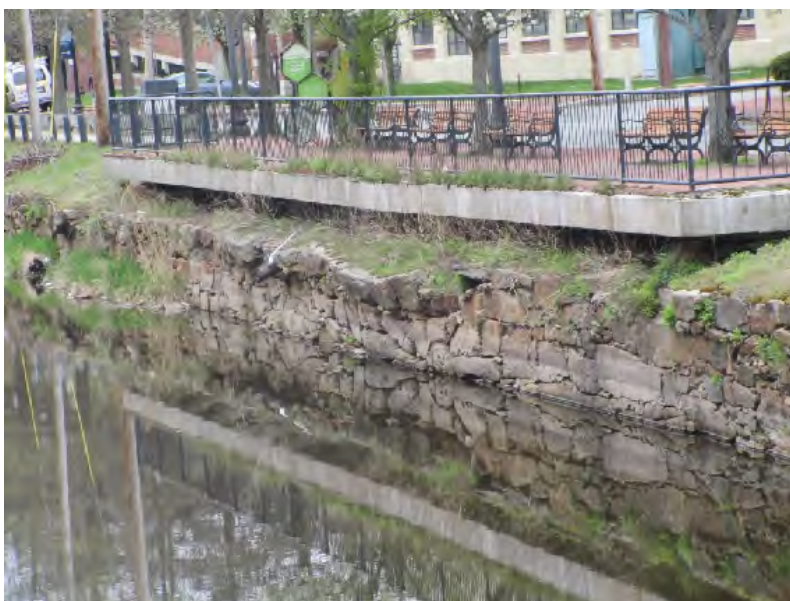
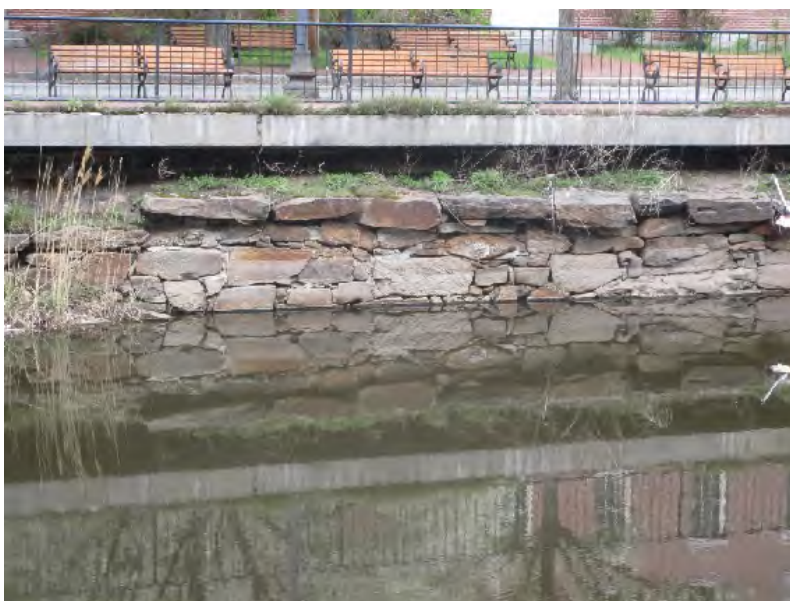
Wall Section: Item #N18; Station 28 + 40 to 29 + 55; Risk Level 1

Observations: VG; out-of-plumb leaning/bowing significantly into canal; unstable; many top stones pushing into canal; major open voids; large concrete public observation deck above wall with benches. See photos below.

Recommendations: Rebuild this wall section with stone construction to match existing (top portion is in the worst condition)

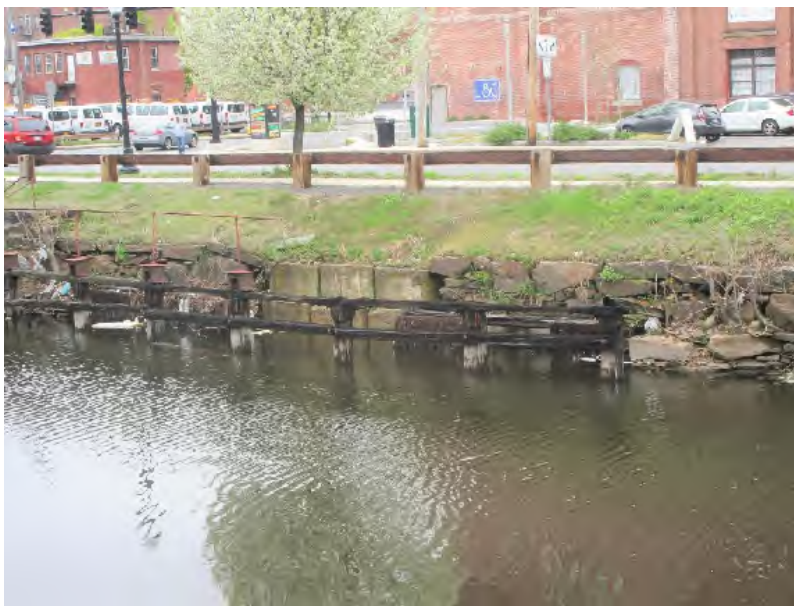
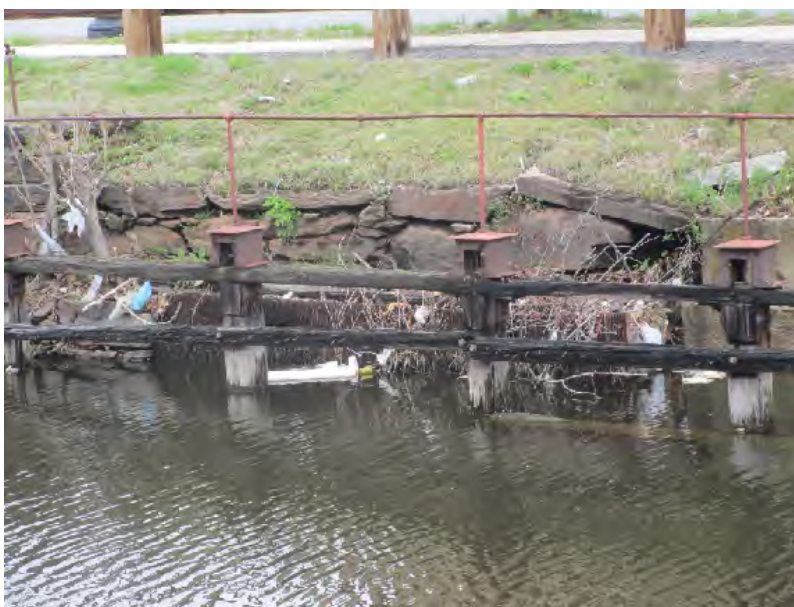
Wall Section: Item #N24; Station 41 + 50 to 42 + 70; Risk Level 2

Observations: Heavy VG; variable plumbness; questionable stability; poorly laid wall with variable stone sizes; many large open joints and voids; abandoned utility structure. See photos below.

Recommendations: Demolish existing abandoned utility structure; Rebuild this wall section with stone construction to match existing.

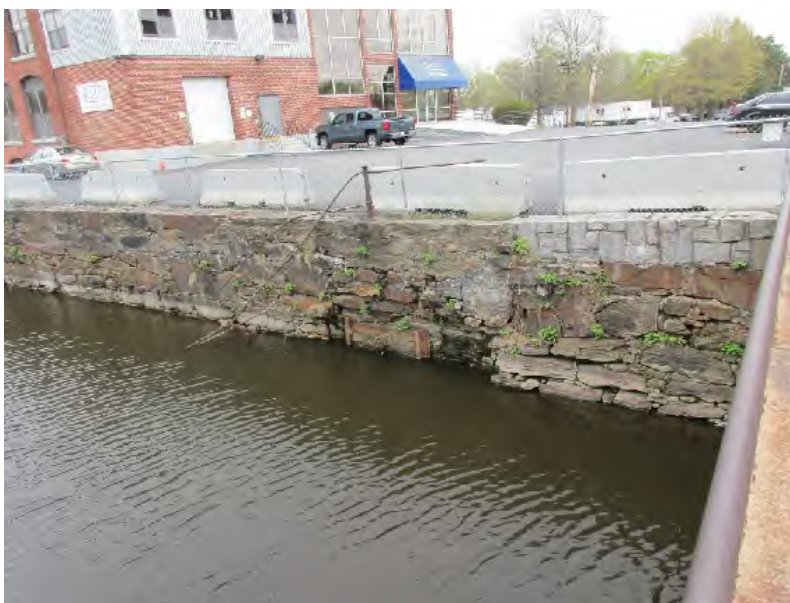
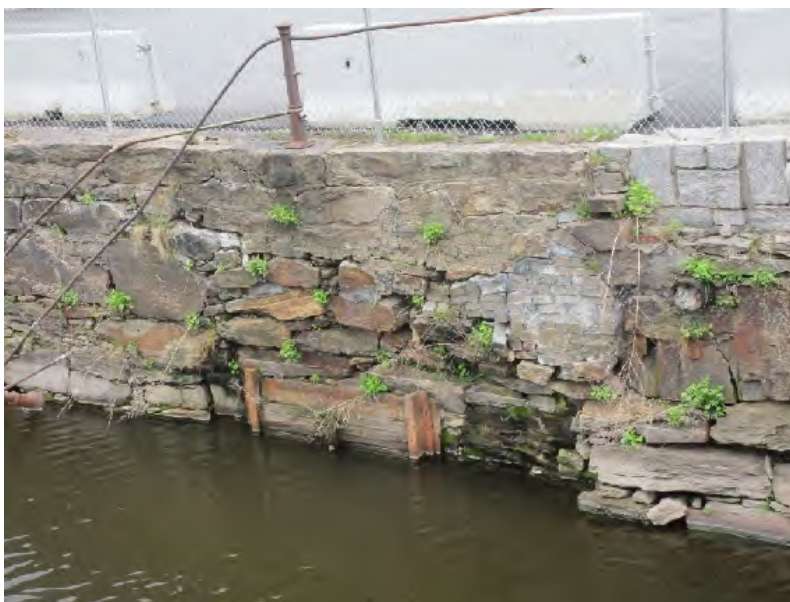
Wall Section: Item #S15; Station 10 + 10 to 10 + 25; Risk Level 2

Observations: VG; plumb; questionable stability; large open voids near base of wall at old, deteriorated gate structure. See photos below.

Recommendations: Demolish existing abandoned gate structure; Rebuild this wall section with stone construction to match existing.

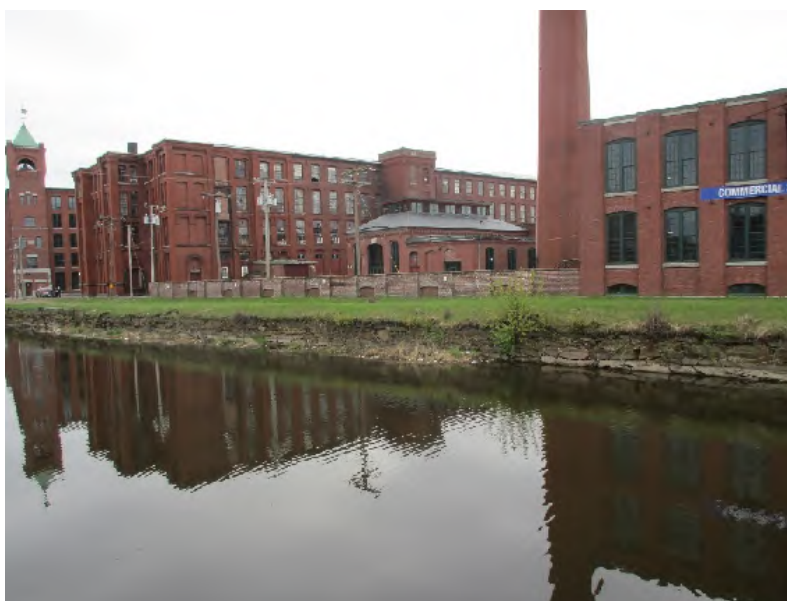
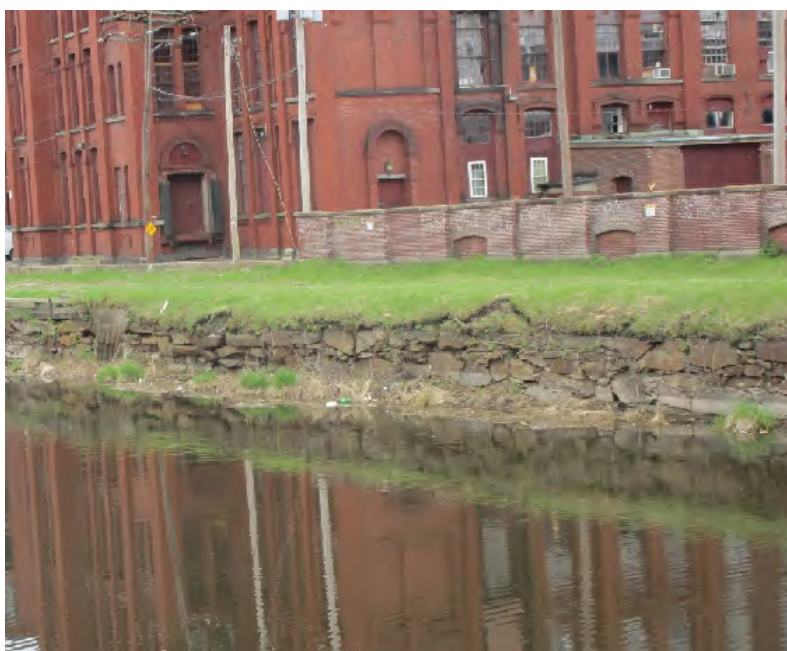
Wall Section: Item #S23; Station 18 + 90 to 22 + 10; Risk Level 2

Observations: Heavy VG; some areas out-of-plumb and leaning outward into canal; appears unstable; erosion along base and top of wall; many dislodged and missing stones. See photos below.

S23	N - P	18 + 90	22 + 10	DLSW	6'	Heavy VG; some areas out-of-plumb and leaning outward into canal; appears unstable; erosion along base & top of wall; many dislodged & missing stones;	Rebuild wall	2
S24	O - P	22 + 10	22 + 75	CONC, MTL	7'	Abandoned metal & concrete intake structure; metal is corroded and conceals concrete wall; could not access for inspection	Demo steel framing items and conduct wall inspection	3
S25	O - P	22 + 75	23 + 45	DLSW	7'	VG; 50 LF of wall to face of bridge appears unstable & out-of-plumb with top leaning significantly into canal	Rebuild wall	1
S26	P - Q	23 + 45	26 + 30	DLSW	6'	Heavy VG; out-of-plumb and leaning into canal; appears unstable; wall is wavy along its length; major open joints & large voids; dislodged stones pushed outward in many locations, especially along top	Rebuild wall	1
S27	Q - R	26 + 30	27 + 80	DLSW, SHCT	7'	VG; out-of-plumb and top half of wall is pushed out and leaning into canal; appears unstable; past shotcrete repair is failing; missing stones; dislodged stones	Rebuild wall	1

Recommendations: Rebuild this wall section with stone construction to match existing.

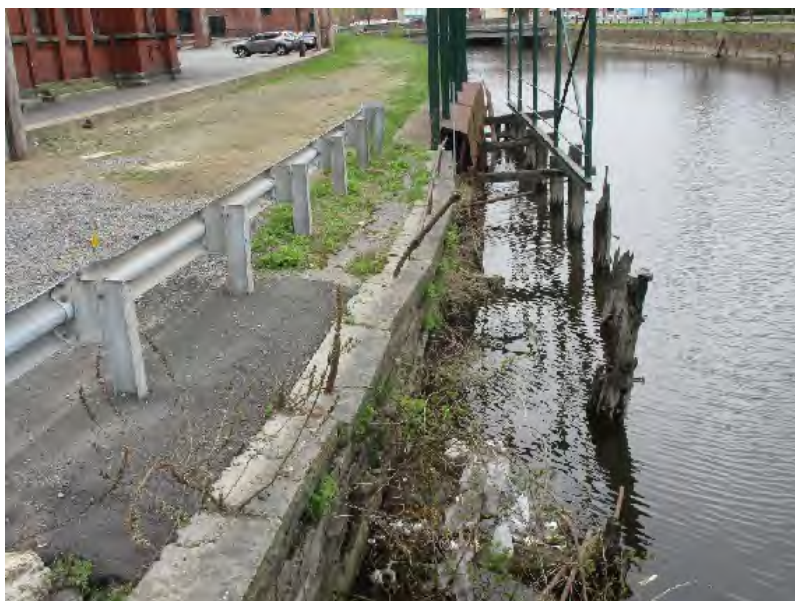
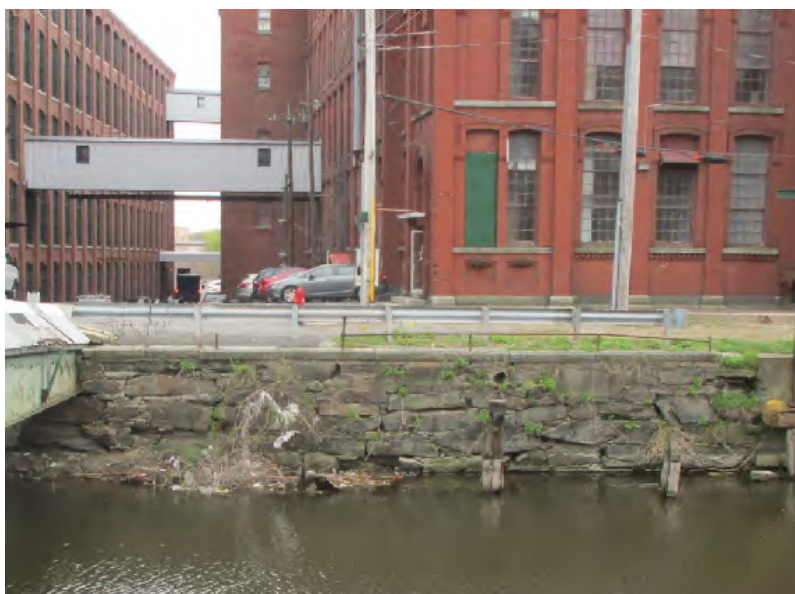
Wall Section: Item #S25; Station 22 + 75 to 23 + 45; Risk Level 1

Observations: VG; 50 LF of wall to face of bridge appears unstable and is out-of-plumb with top leaning significantly into canal. See photos below.

Recommendations: Rebuild this wall section with stone construction to match existing.

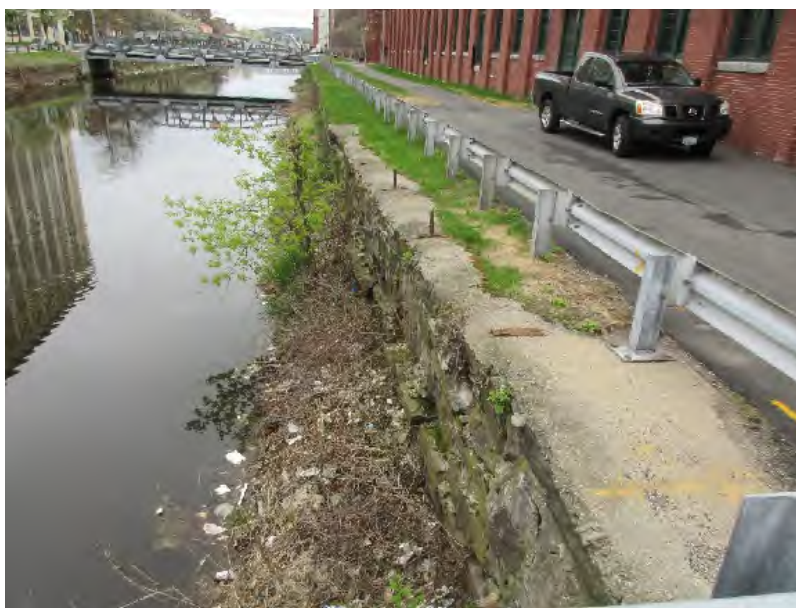
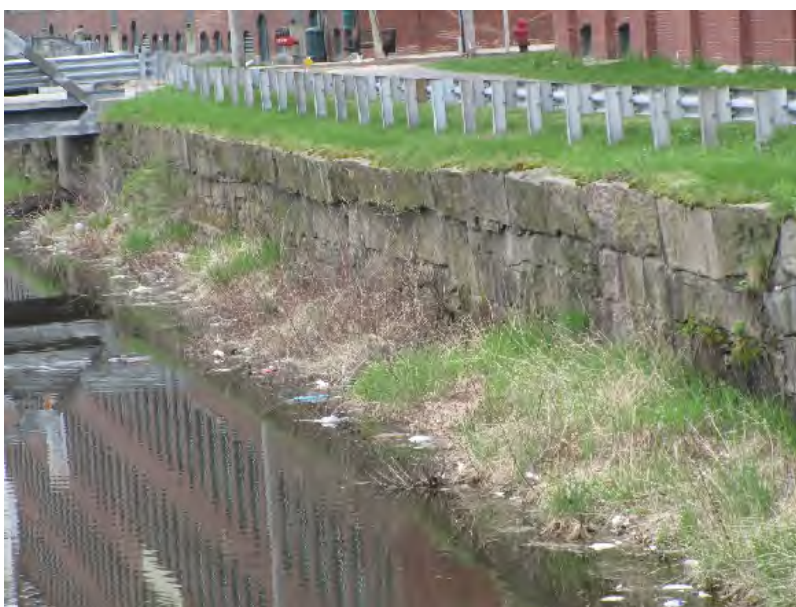
Wall Section: Item #S26; Station 23 + 45 to 26 + 30; Risk Level 1

Observations: Heavy VG; out-of-plumb and leaning into canal; appears unstable; wall is wavy along its length; major open joints and large voids; dislodged stones pushed outward in many locations, especially along top. See photos below.

Recommendations: Rebuild this wall section with stone construction to match existing.

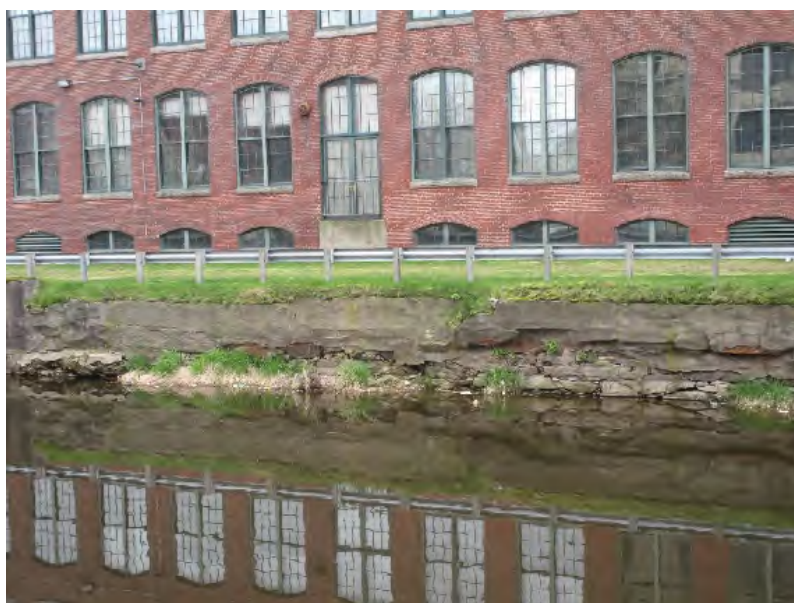
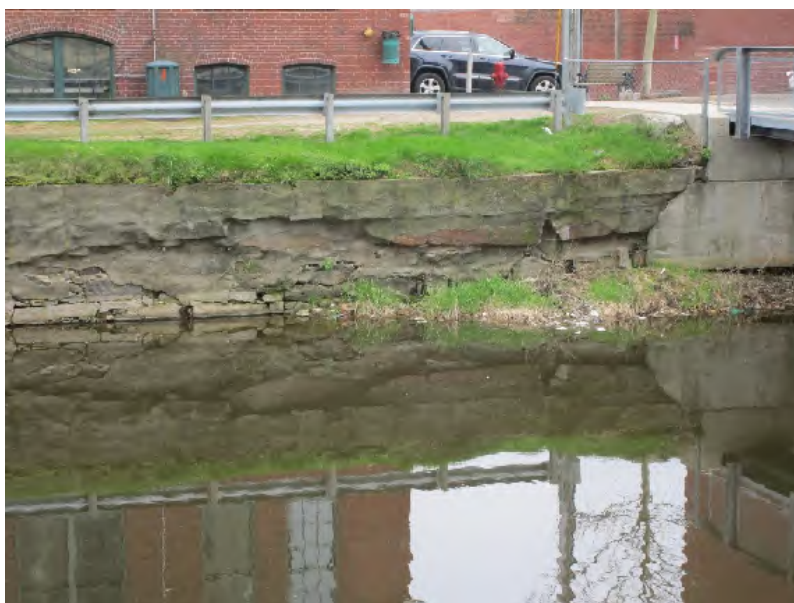
Wall Section: Item #S27; Station 26 + 30 to 27 + 80; Risk Level 1

Observations: VG; out-of-plumb and top half of wall is pushed out and leaning into canal; appears unstable; past shotcrete repair is failing; missing stones; dislodged stones. See photos below.

Recommendations: Rebuild this wall section with stone construction to match existing.

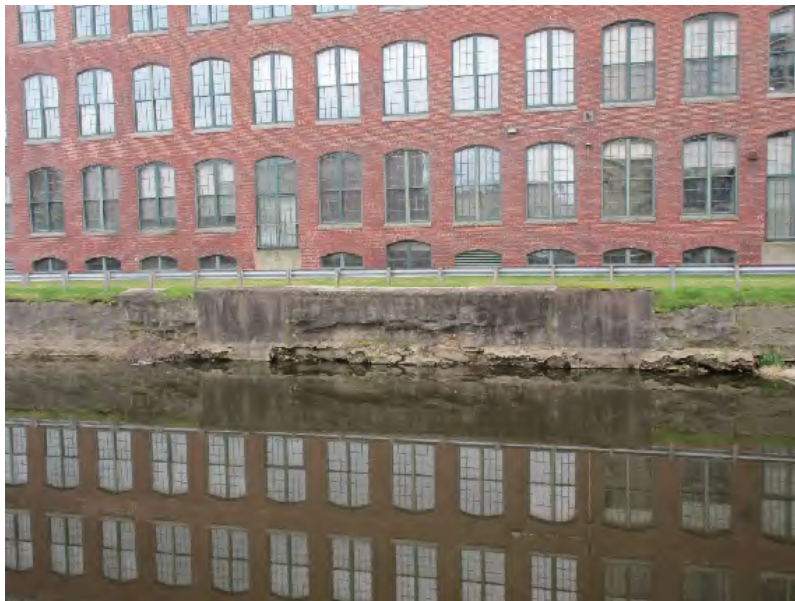
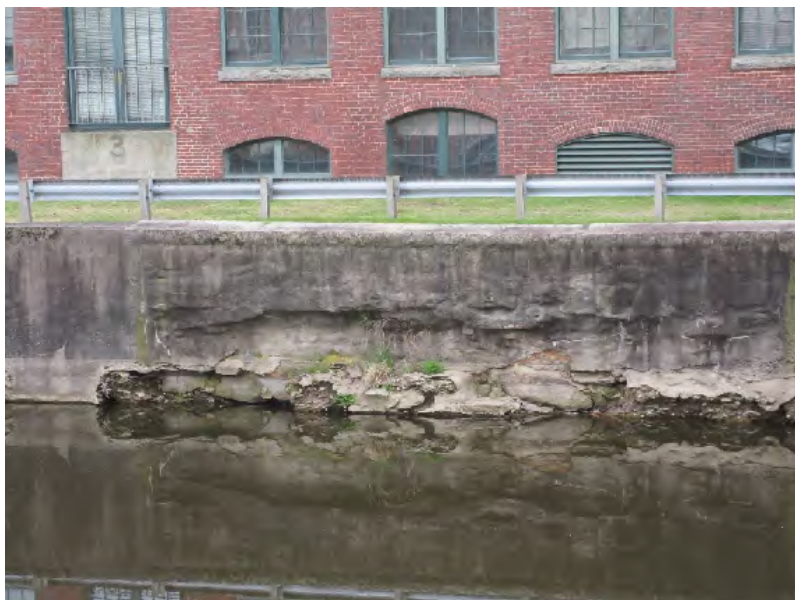
Wall Section: Item #S28; Station 27 + 80 to 28 + 40; Risk Level 1

Observations: Section of concrete wall is in very poor condition – especially the lower half – with severe deterioration and undermining at its base; past shotcrete repair is failing; pronounced lean into canal; appears unstable. See photos below.

S28	Q - S	27 + 80	28 + 40	CONC	8'	Section of concrete wall is in very poor condition – especially the lower half – with severe deterioration and undermining at its base; past shotcrete repair is failing; pronounced lean into canal; appears unstable	Rebuild wall	1
S29	R - S	28 + 40	29 + 50	DLSW, SHCT	7'	DLSW concealed by past shotcrete repair that is flaking off; appears stable; plumb; one large void in wall	RV; monitor; infill one large hole	3
S30	R - S	29 + 50	29 + 70	DLGWR	7'	Dry laid granite block wall repair with combination of granite blocks and crushed stone; assumed that this section of DLSW previously collapsed; alignment is poor; variable plumbness and appears stable	RV; monitor	3
S31	S - T	29 + 70	31 + 25	DLSW, MSW	7'	Heavy VG; out-of-plumb leaning into canal; large open joints & voids; failing mortar in joints; missing stones; old gate structure	Rebuild wall; demo gate structure	2

Recommendations: Demolish concrete wall and rebuild this wall section with stone construction to match existing.

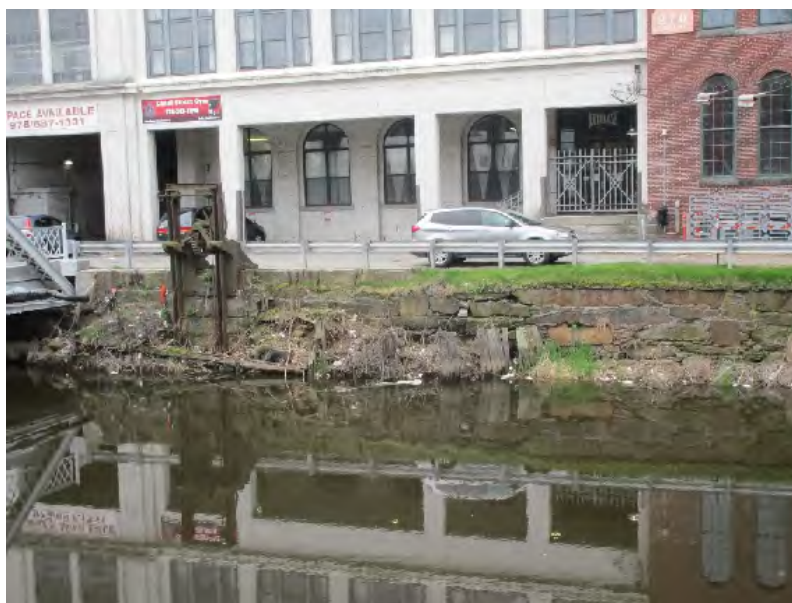
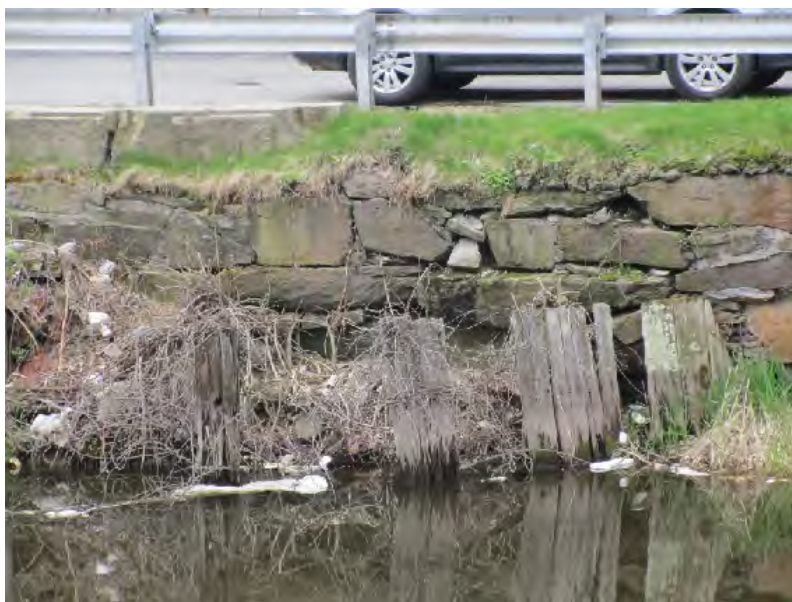
Wall Section: Item #S31; Station 29 + 70 to 31 + 25; Risk Level 2

Observations: Heavy VG; out-of-plumb leaning into canal; large open joints and voids; failing mortar in joints; missing stones; old gate structure; appears unstable. See photos below.

Recommendations: Demolish old gate structure and rebuild this wall section with stone construction to match existing.

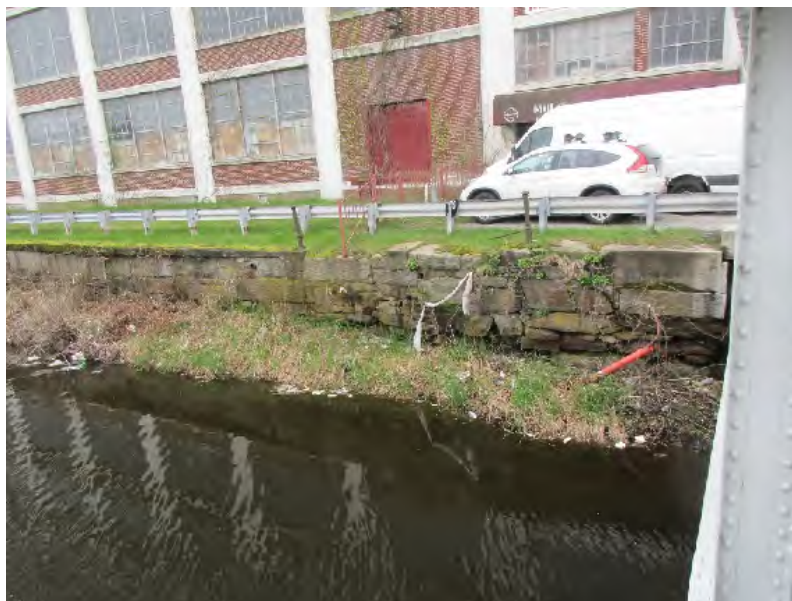
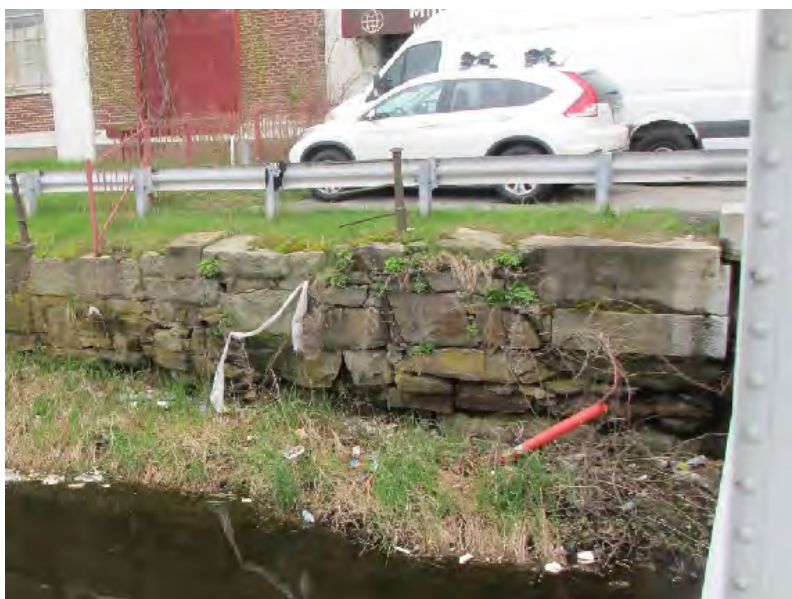
Wall Section: Item #S32; Station 31 + 25 to 31 + 65; Risk Level 1

Observations: This entry is for 25 LF of wall starting at face of bridge; VG; out of-plumb with major leaning into canal; **appears unstable with vehicles currently parked close to face of wall**; earth and VG along base of wall. See photos below.

S32	T - U	31 + 25	31 + 65	DLSW	8'	This entry is for 25 LF of wall starting at face of bridge; VG; out of-plumb with major leaning into canal; appears unstable with vehicles currently parked close to face of wall ; earth & VG along base of wall	Rebuild wall; consider prohibiting parking next to this wall	1
S33	T - U	31 + 65	33 + 25	DLSW, MSW	7'	Heavy VG; DLSW with failing mortar joints for upper areas; out-of-plumb with top stones pushed into canal; questionable stability; earth & VG along base of wall	RV; monitor; reset any dislodged top stones	3
S34	U - V	33 + 25	34 + 05	CONC-FCD DLSW	7'	DLSW appears to have been repaired using formed concrete on exterior face; this concrete facing is cracked, deteriorated, and severely undermined along its base; fairly plumb; questionable stability	Rebuild wall (impractical to repair)	2
S35	U - V	34 + 05	35 + 10	CONC	7'	Concrete wall along abandoned intake structure; wall appears plumb & stable but is concealed by intake structure framework	Demo intake structure & conduct closer inspection of wall	3

Recommendations: Rebuild this wall section with stone construction to match existing. **Prohibit parking of vehicles along this wall to minimize future surcharge loading.**

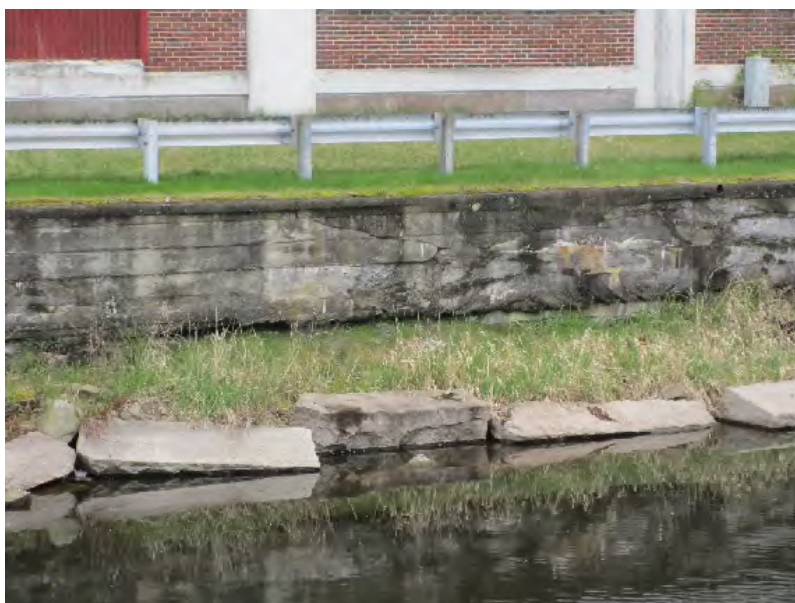
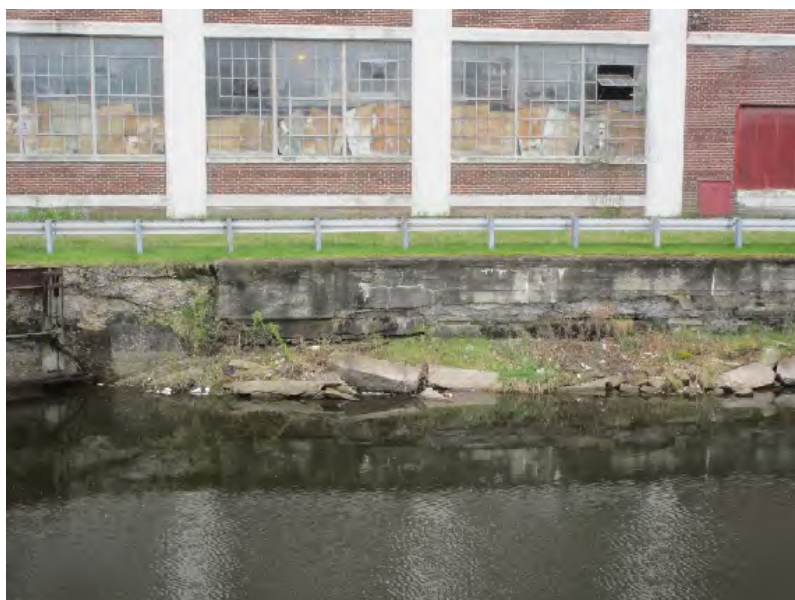
Wall Section: Item #S34; Station 33 + 25 to 34 + 05; Risk Level 2

Observations: DLSW appears to have been repaired using formed concrete on exterior face; this concrete facing is cracked, deteriorated, and severely undermined along its base; questionable plumbness; questionable stability. See photos below.

Recommendations: Demolish existing cracked, deteriorated concrete and rebuild this wall section with stone construction to match existing.

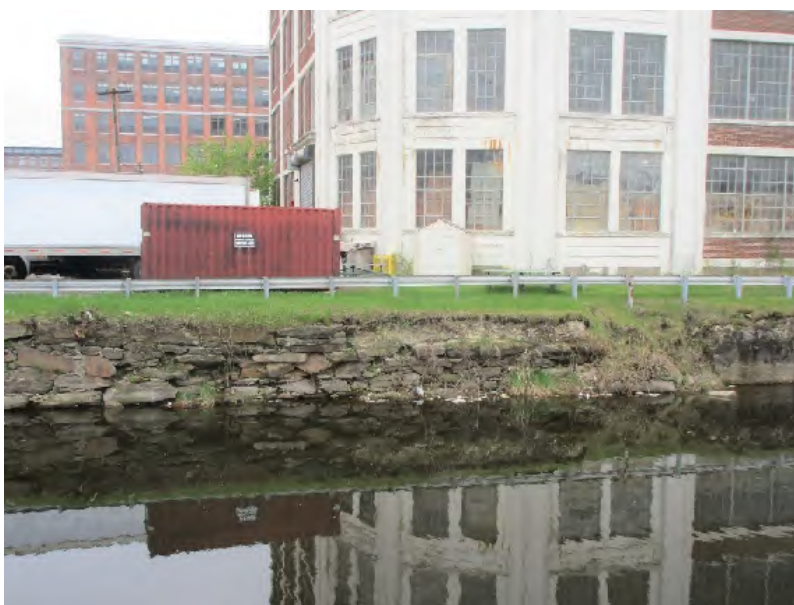
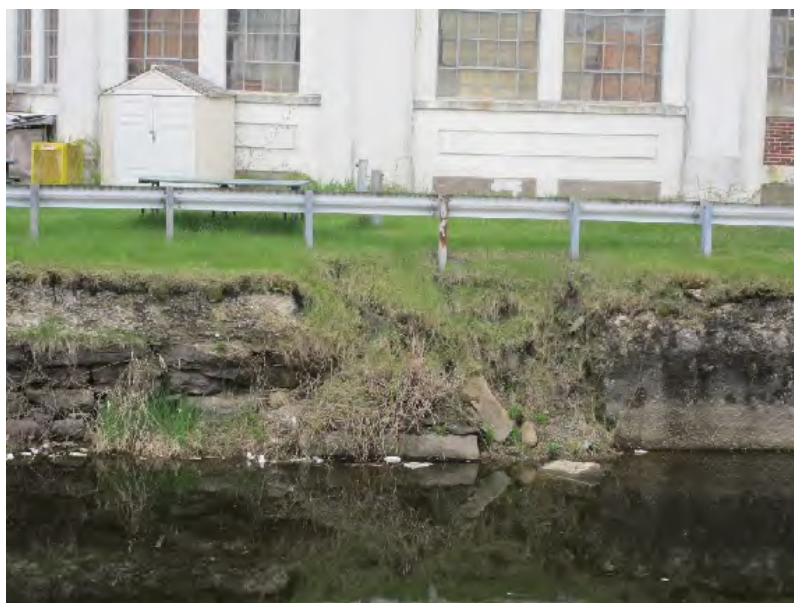
Wall Section: Item #S36; Station 35 + 10 to 35 + 70; Risk Level 1

Observations: VG; out-of-plumb and leaning into canal; appears unstable with areas that have partial and total collapse; large open joints and voids; missing stones. See photos below.

S36	V - W	35 + 10	35 + 70	DLSW	7'	VG; out-of-plumb and leaning into canal; appears unstable with areas that have partial & total collapse; large open joints & voids; missing stones	Rebuild wall	1
S37	U - W	35 + 70	36 + 40	DLSW	7'	VG; plumb; appears stable; minor open joints	RV; monitor	4
S38	W - Y	36 + 40	40 + 00	DLSW, MSW, CONC	7'/11'	VG; plumb; appears stable; major open joints & large voids; DLSW lower wall and MSW/CONC upper wall	RV; monitor	3
S39	Y	40 + 00	40 + 50	CONC BRIDGE	7'	Union Street Bridge (1939 construction) has major concrete deterioration and exposed rebar on each face, railings, and abutments	Conduct detailed structural condition assessment and repair all deteriorated concrete	3
S40	Y - Z	40 + 50	41 + 80	DLSW, MSW, CONC	7'/11'	VG; plumb; appears stable; moderate open joints; some dislodged stones; DLSW lower wall and MSW/CONC upper wall	RV; monitor	4
S41	Y - Z	41 + 80	41 + 95	DLSW, WOOD	7'	DLSW combined with rotten wood framework; abandoned utility structure; heavy VG; appears unstable; partial collapse for top portion; major open joints & voids; missing stones; erosion	Rebuild wall; demo wooden utility structure	1

Recommendations: Rebuild this wall section with stone construction to match existing.

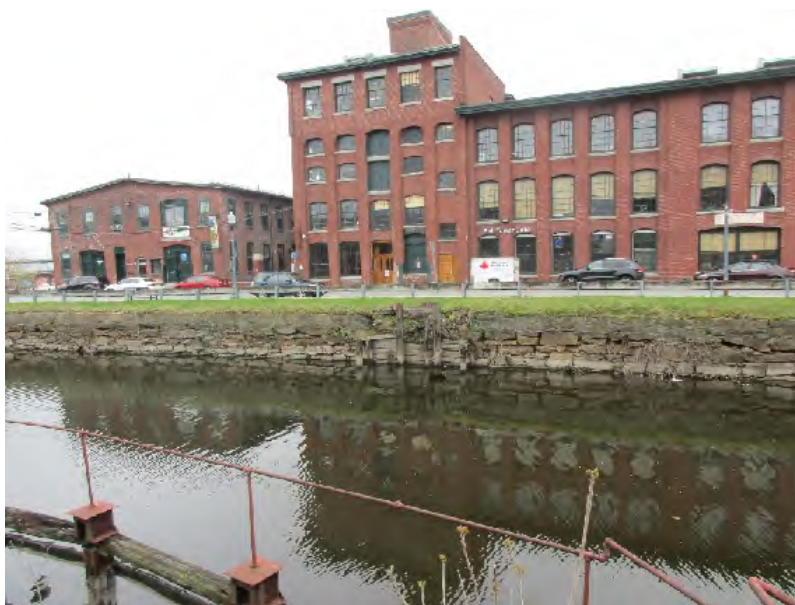
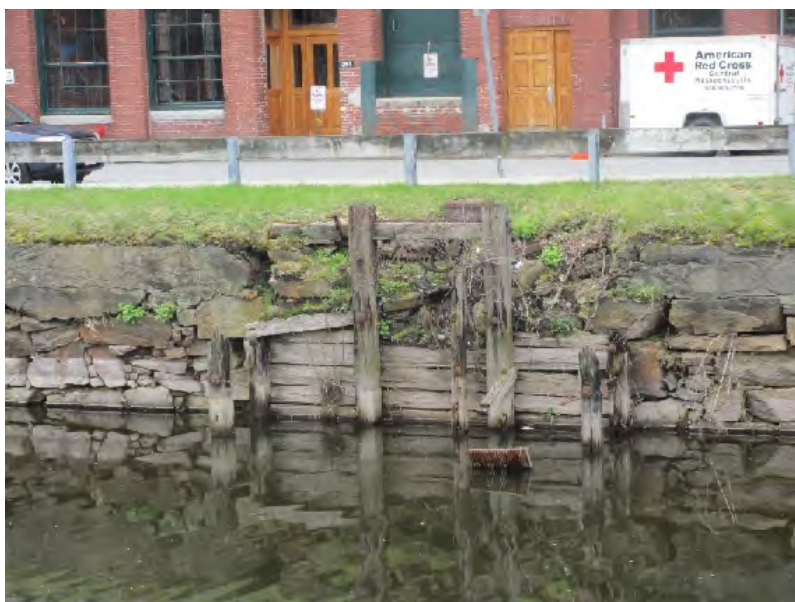
Wall Section: Item #S41; Station 41 + 80 to 41 + 95; Risk Level 1

Observations: DLSW combined with rotten wood framework; abandoned utility structure; heavy VG; appears unstable; partial collapse for top portion; major open joints and voids; missing stones; erosion. See photos below.

Recommendations: Demo wooden utility structure and rebuild this wall section with stone construction to match existing.

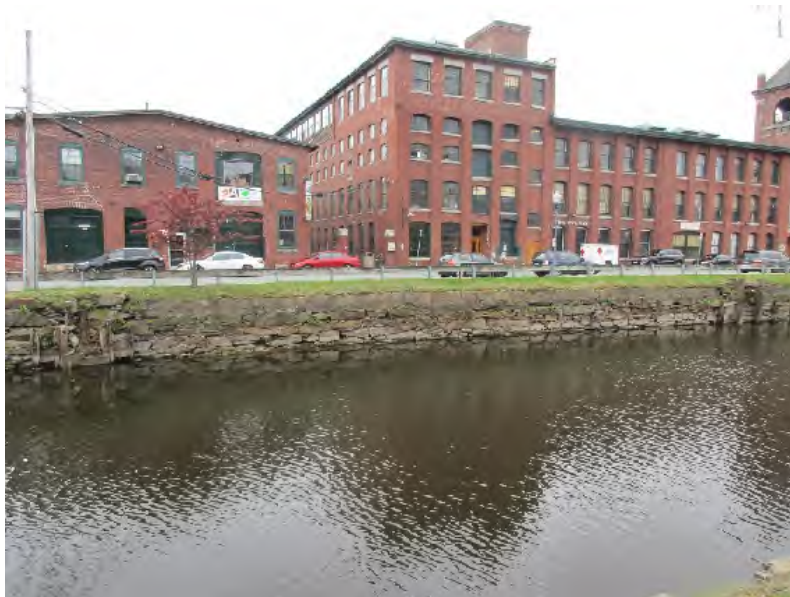
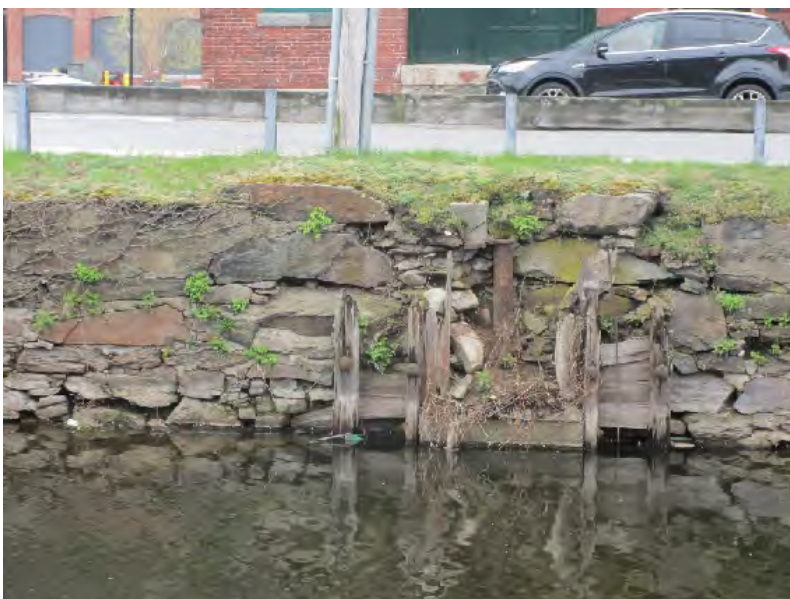
Wall Section: Item #S43; Station 43 + 00 to 43 + 20; Risk Level 1

Observations: DLSW combined with rotten wood framework; abandoned utility structure; heavy VG; appears unstable; partial collapse for top portion; major open joints and voids; missing stones; erosion. See photos below.

Recommendations: Demo wooden utility structure and rebuild this wall section with stone construction to match existing.
