CONDITION ASSESSMENT OF CANAL WALLS REPORT

North Canal
Lawrence, MA

0228526.02
City of Lawrence, MA
May 2019

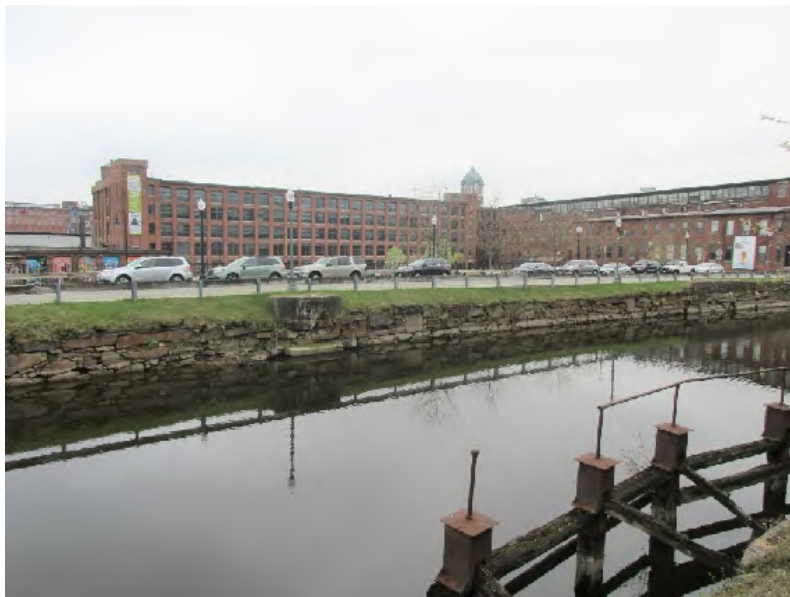
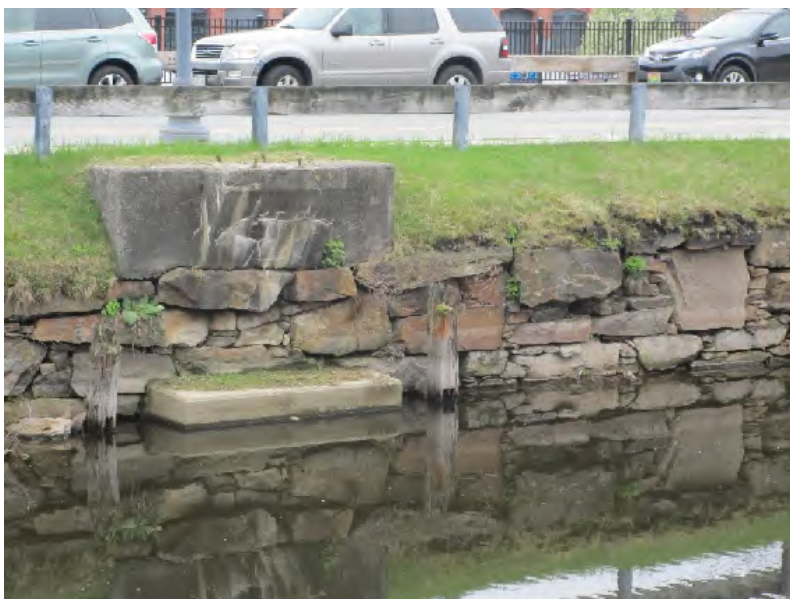
Wall Section: Item #S45; Station 44 + 50 to 45 + 90; Risk Level 2

Observations: VG; out-of-plume and leaning into canal; appears unstable; major open joints and gaps; dislodged stones; abandoned concrete post foundation atop unstable DLSW stones; erosion along top supporting sidewalk and street. See photos below.

#	NEAR POINTS	START LOC'N	END LOC'N	TYPE	H	OBSERVATIONS	RECOMMENDATIONS	RL 1-5
S45	AA - CC	44 + 50	45 + 90	DLSW	5'	VG; out-of-plume and leaning into canal; appears unstable; major open joints & gaps; dislodged stones; abandoned concrete post foundation atop DLSW stones which appear to be unstable; erosion along top supporting sidewalk and street	Rebuild wall	2
S46	BB - DD	45 + 90	47 + 00	MSW	6-8'	Modern stone masonry wall below and in vicinity of bridge at Station Point CC is in good condition	No work required	5
S47	CC - EE	47 + 00	51 + 35	DLSW	5'	VG; appears plumb & stable; poorly-built wall with variable & irregular surface; large open joints & voids; dislodged stones	RV; monitor	3
S48	EE - FF	51 + 35	54 + 05	DLSW	5'	VG; out-of-plumb and top stones are leaning into canal; appears unstable; poorly-built wall with variable & irregular surface; large open joints & voids; dislodged stones; last portion of wall was previously replaced with riprap stone, likely due to a wall collapse; wall ends near canal outlet which is located at Station 54 + 05	Rebuild wall	2

Recommendations: Demo concrete post-foundation structure and rebuild this wall section with stone construction to match existing.

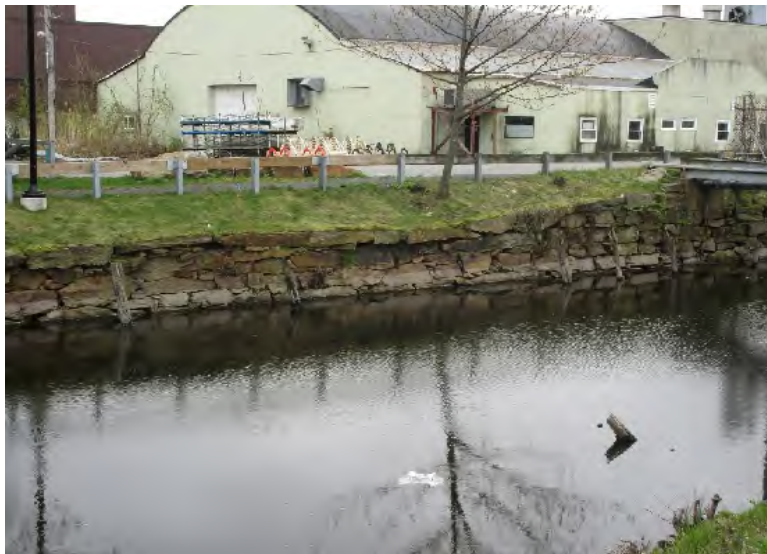
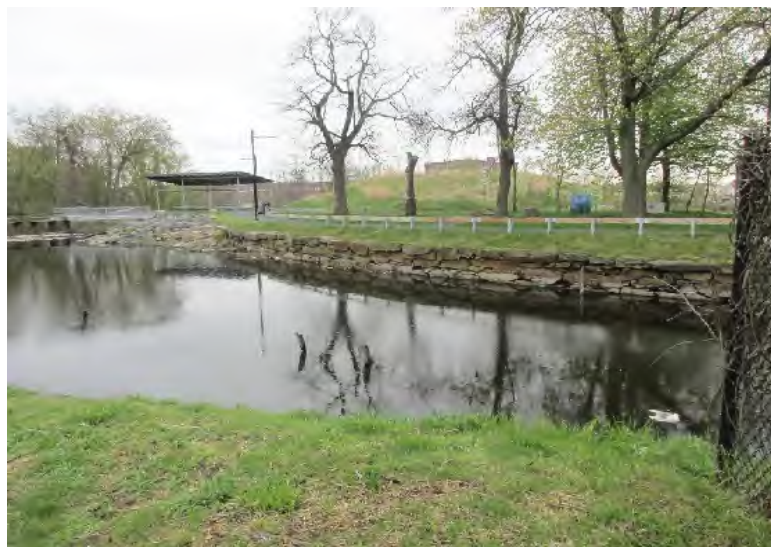
Wall Section: Item #S48; Station 51 + 35 to 54 + 05; Risk Level 2

Observations: VG; out-of-plumb and top stones are leaning into canal; appears unstable; poorly-built wall with variable and irregular surface; large open joints and voids; dislodged stones; last portion of wall was previously replaced with riprap stone, likely due to a wall collapse; wall ends near canal outlet which is located at Station 54 + 05. See photos below.

Recommendations: Demo concrete post foundation structure and rebuild this wall section with stone construction to match existing.
