**Berry's Brook Surface Water**  
**Sampling Techniques, Observations and Results**  
By New Hampshire Department of Environmental Services  
December 20, 2016  
Greenland, New Hampshire

On December 20, 2016 Steve Roy of the NHDES Water Division and Drew Hoffman of the NHDES Waste Management Division sampled five surface water stations along Berry's Brook in Greenland and Rye, NH. Samples were collected for analysis of perfluorinated sulfonic and carboxylic acids (PFCs) per EPA Method 537M and 1,4-dioxane per EPA Method 522. PFC samples were collected into two, non-preserved, 250 milliliter polypropylene bottles. 1,4-Dioxane samples were collected into one 1-liter amber glass bottles preserved with sodium bisulfate ( $\text{NaHSO}_4$ ). A summary of sample locations are shown in the photos and table below:

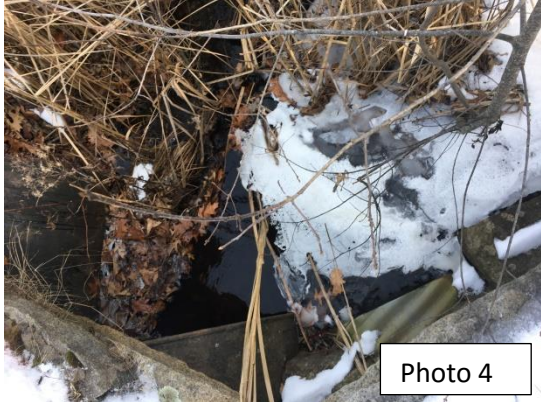
Photo 4

Three culverts converge at this sampling location. Only one culvert appeared to be conveying a sufficient volume of water to keep the water surface relatively ice free. There had been recent precipitation (0.4 inches of rain on 12/18) in the days prior to sampling causing overland flow between area wetlands. Both standard and duplicate samples were collected from this location (Photos 4 & 5 below). Photo 5 demonstrates sampling technique for PFC sample collection. Photo 6 shows sampling technique for 1,4-dioxane sample collection (note use of designated sterile bottle for transfer of water to preserved sample bottle). A field duplicate was also prepared at this location by pouring lab-supplied deionized water from transport container to sample containers (Photo 7).

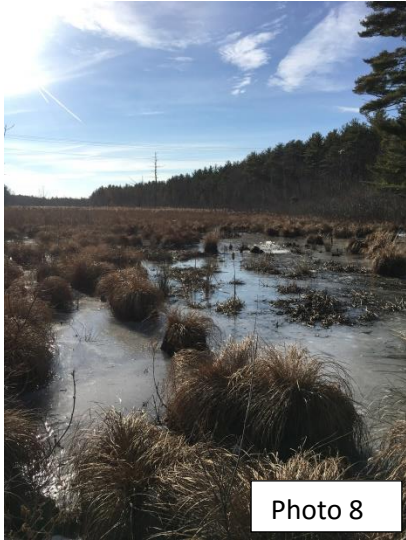
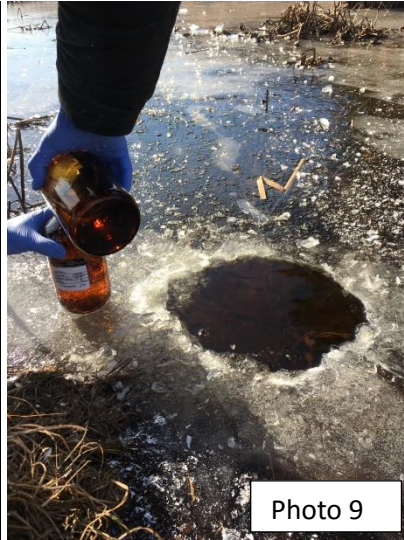
Sample collected from ponded wetland to the west of the former railroad tracks and several hundred yards south of CLK\_SW10. Several inches of ice were removed using a steel ice chisel.

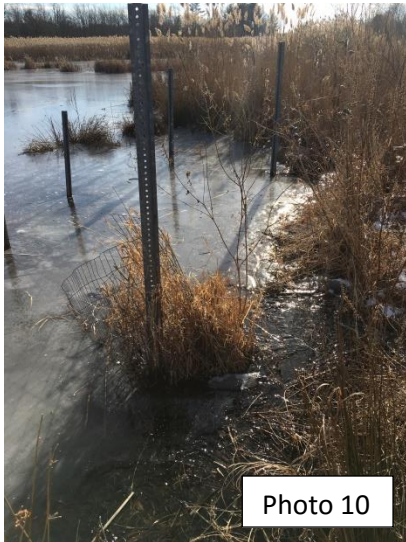
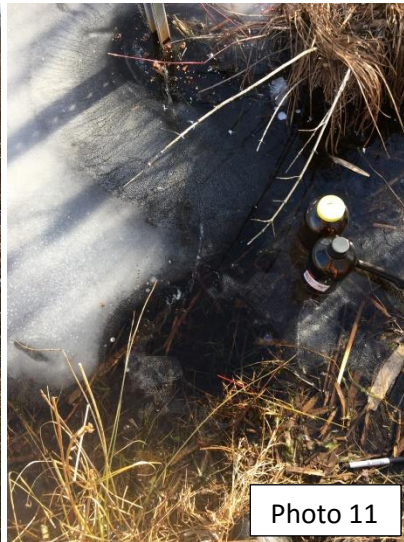
Sample collected from ponded wetland to the east of the former railroad tracks opposite of CLK\_SW11. Minimal ice removal was required.

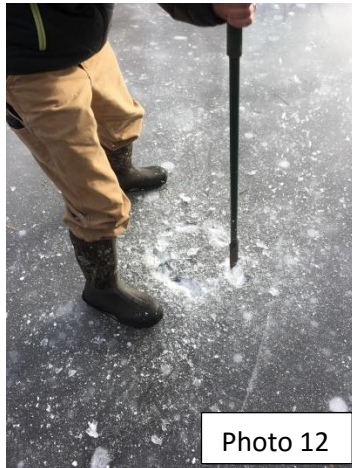
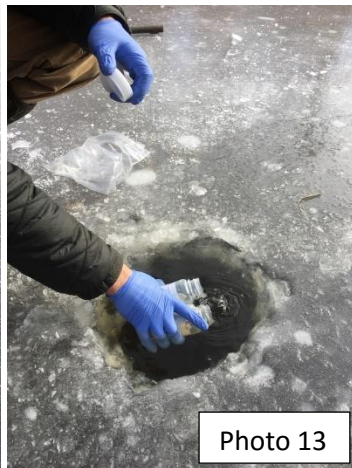
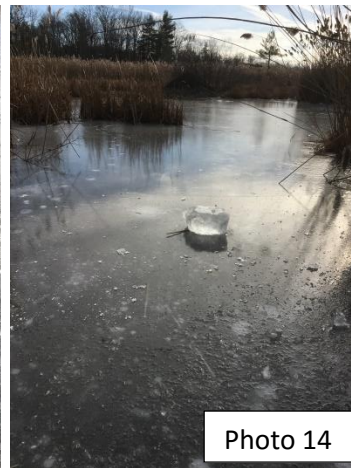
Sample collected from ponded wetland to the east of the former railroad tracks. Approximately six inches of ice had to be removed using a steel ice chisel prior to sample collection.

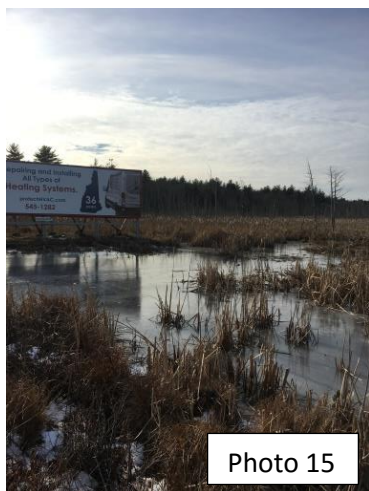
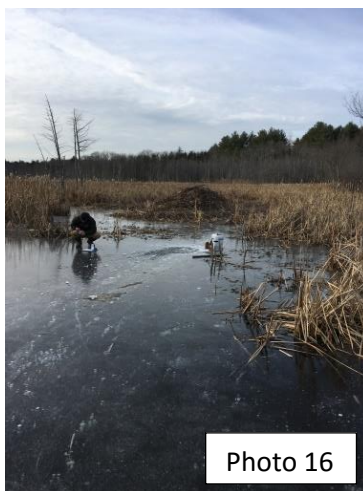
Sample collected from ponded wetland to the west of Lafayette Road. Approximately six inches of ice had to be removed using a steel ice chisel prior to sample collection.

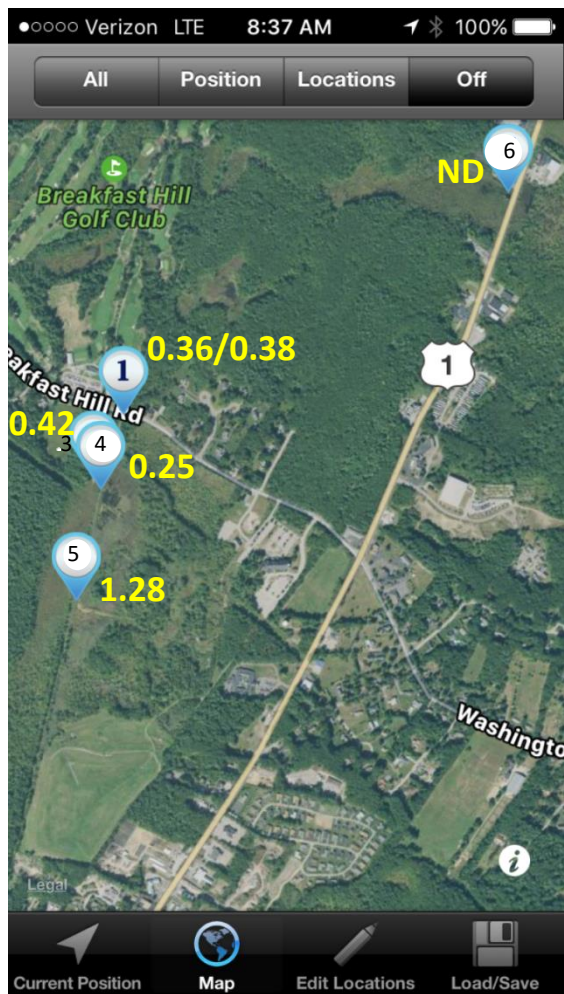
Map showing 1,4-dioxane results (ug/L)

Location	Sample ID	1,4-Dioxane (1) results (ug/L)	PFOA & PFOS(2) results (ng/L)
1	CLK-SW10	0.36/0.38 (dup)	297/308 (dup)
3 (located near 4)	CLK-SW11	0.42	311
4	CLK-SW12	0.25	410
5	CLK-SW13	1.28	1250
6	CLK-SW14	ND (0.20)	90

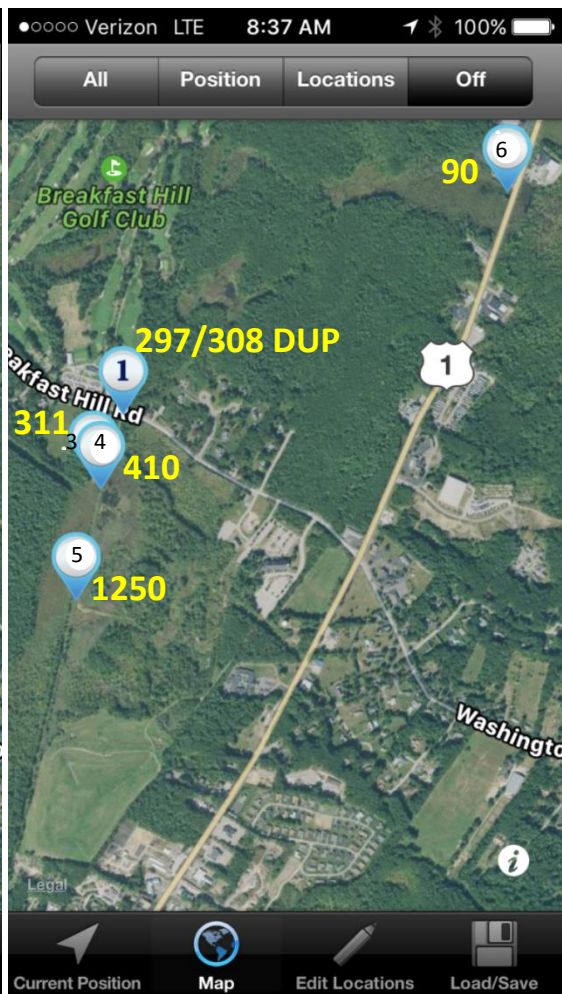
Map showing PFOA+PFOS results (ng/L)
