Exhibit 1: Lack of Required Signage

Exhibit 2: Lack of Handicapped-Accessible Entrances to Park

Exhibit 3: Lack of Suitable Crosswalks

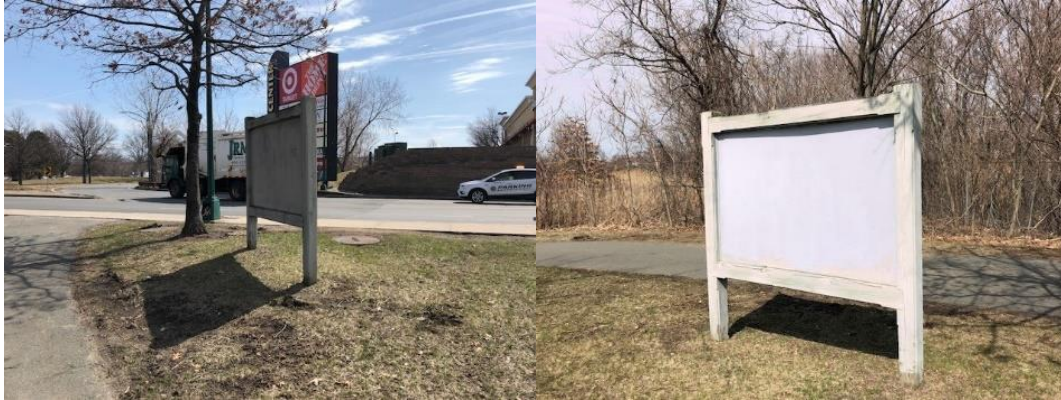
The signboard above is located at the entrance to the Gateway Center shopping plaza and was presumably intended to house a sign welcoming patrons to Gateway Park and/or other park signage, but both sides of the signboard are blank.

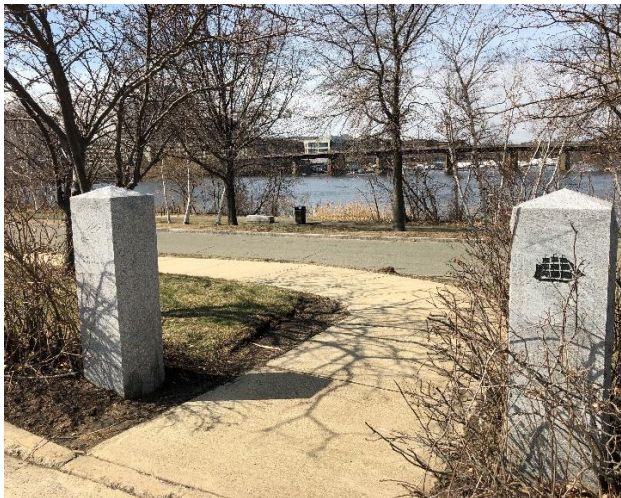
These granite signposts are located adjacent to the designated parking area and were presumably intended to house required park signage, but they merely contain depictions of a ship (right) and alewife fish (left).

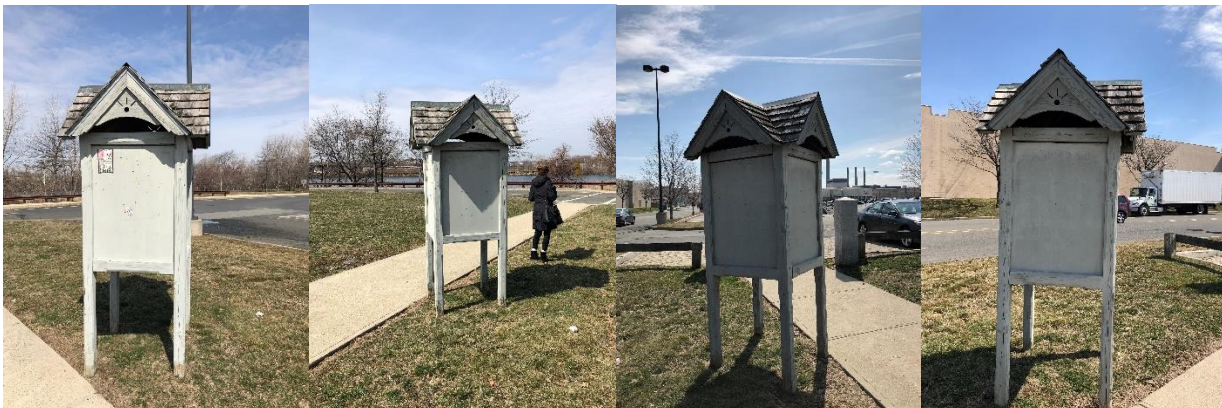
Presumably the kiosk above, which is located adjacent to the designated parking area, was intended to house park signage and interpretive displays, but all four sides of the kiosk are blank (aside from a pet grooming business ad).

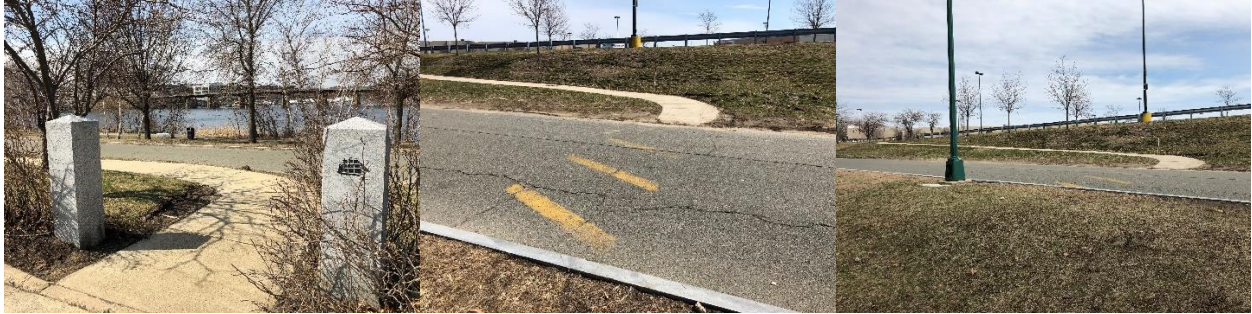
One entrance to the park from the parking area contains a sloping sidewalk from the parking area down towards the park and a crosswalk across Mystic View Road, but there is no connection to the park on the other side of the road. A wheelchair would have to stop at the curb and would be stuck in the road with nowhere to go.

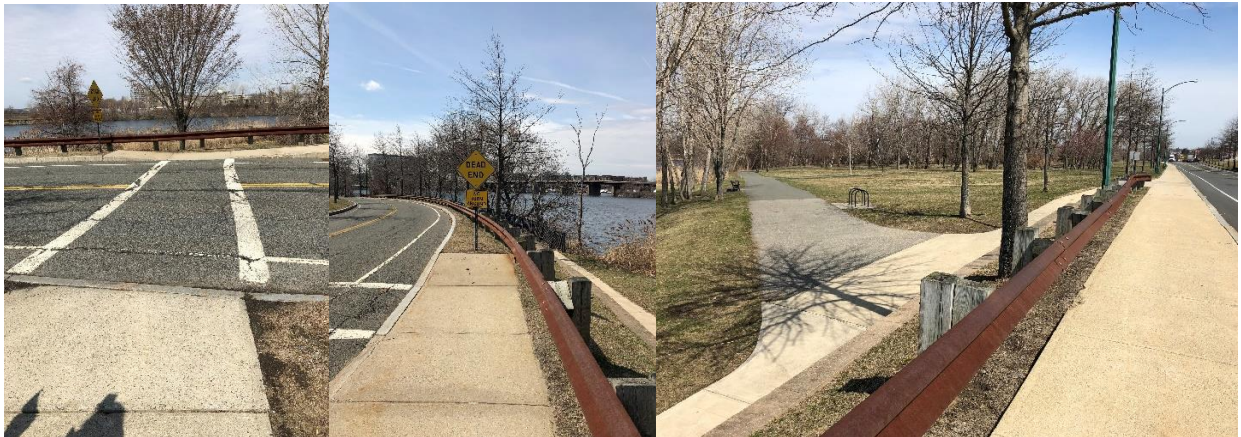
A second entrance to the park from the parking area connects to a sidewalk on the other side of Mystic View Road, but there is a guardrail blocking the entrance to the park at that location (if you turn left, the sidewalk dead ends and if you turn right, there is an entrance to the park further up, but there is a very sharp dip in the sidewalk going down into the park at that location that would not be suitable for wheelchairs).

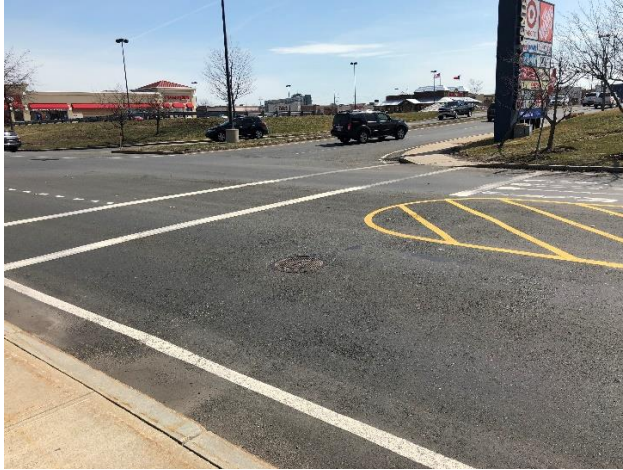
The crosswalk connecting the entrance to the Gateway Center Shopping Plaza to the park across Mystic View Road is not well-marked and there is no signage warning drivers about pedestrians. This intersection is very busy, and it would be dangerous for pedestrians to cross here.

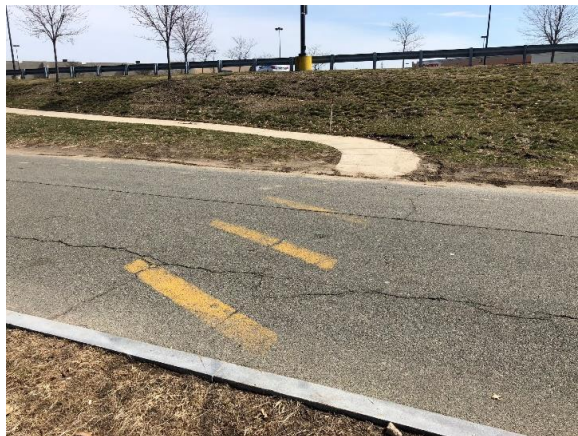
One crosswalk connecting the designated parking area to the park across Mystic View Road is not well-marked (paint is extremely faded) and there is no signage warning drivers about pedestrians.

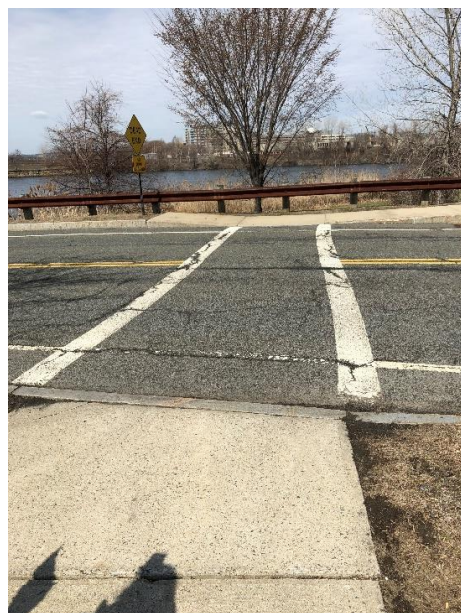
A second crosswalk connecting the designated parking area to the park across Mystic View Road is not well-marked and there is no signage warning drivers about pedestrians.

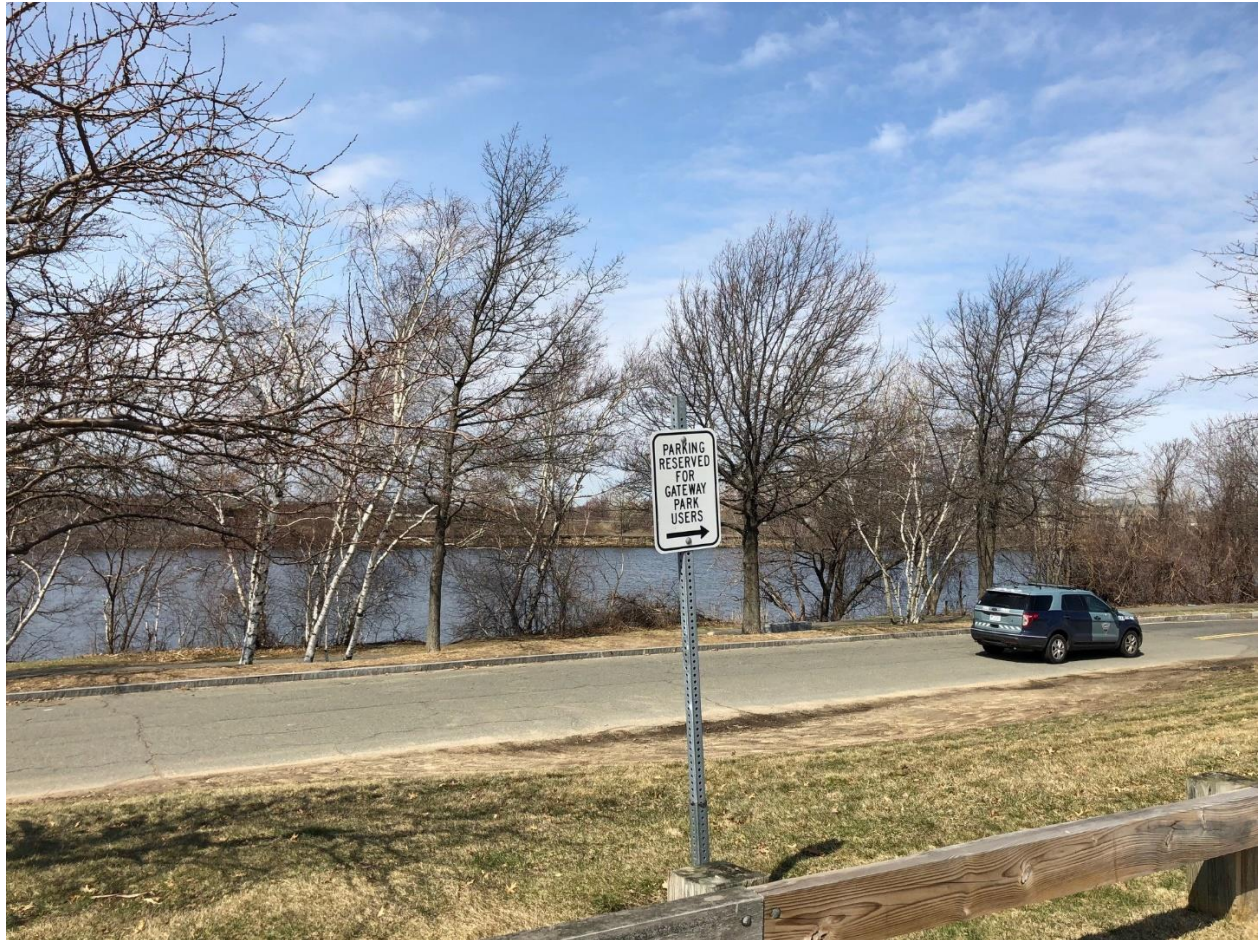
Exhibit 4: Lack of Required Parking Signage

The single sign indicating the designated parking area for park users is located at the farthest end of the parking area from the entrance to the designated parking area, so most potential park patrons probably do not even see it. The designated parking area consists of 39 spaces (supposed to be 40), so one sign is not sufficient to inform potential park users about where to park.

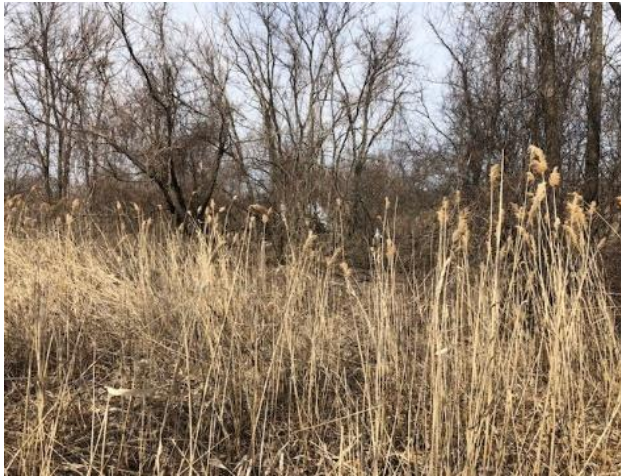
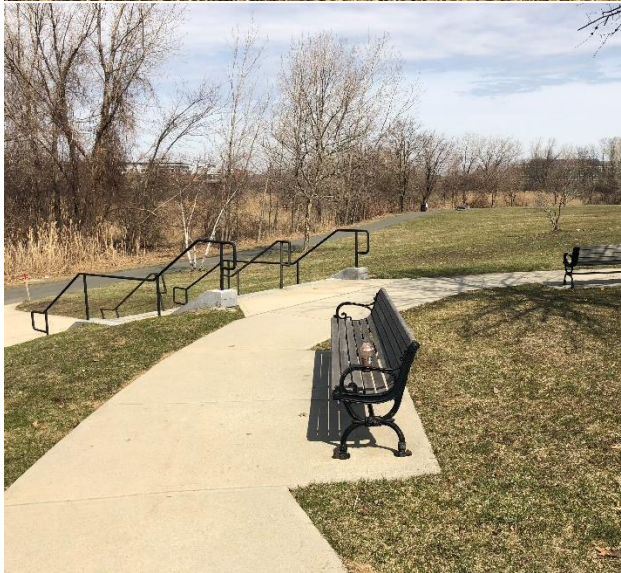
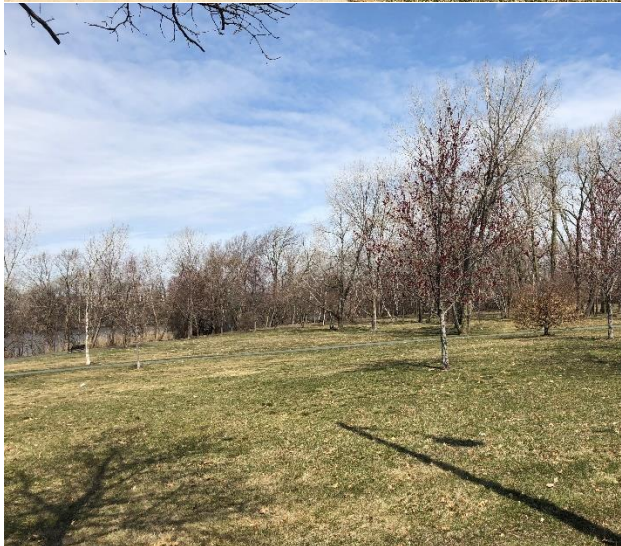
Exhibit 5: Lack of Appropriate View Corridors toward the Waterfront

These photos are just a few examples illustrating the lack of view corridors at the park. Even in early April, before the vegetation has filled in, there are very few areas where you can see through to the Mystic River.
