CONDITION ASSESSMENT OF CANAL WALLS REPORT

North Canal
Lawrence, MA

0228526.02
City of Lawrence, MA
May 2019

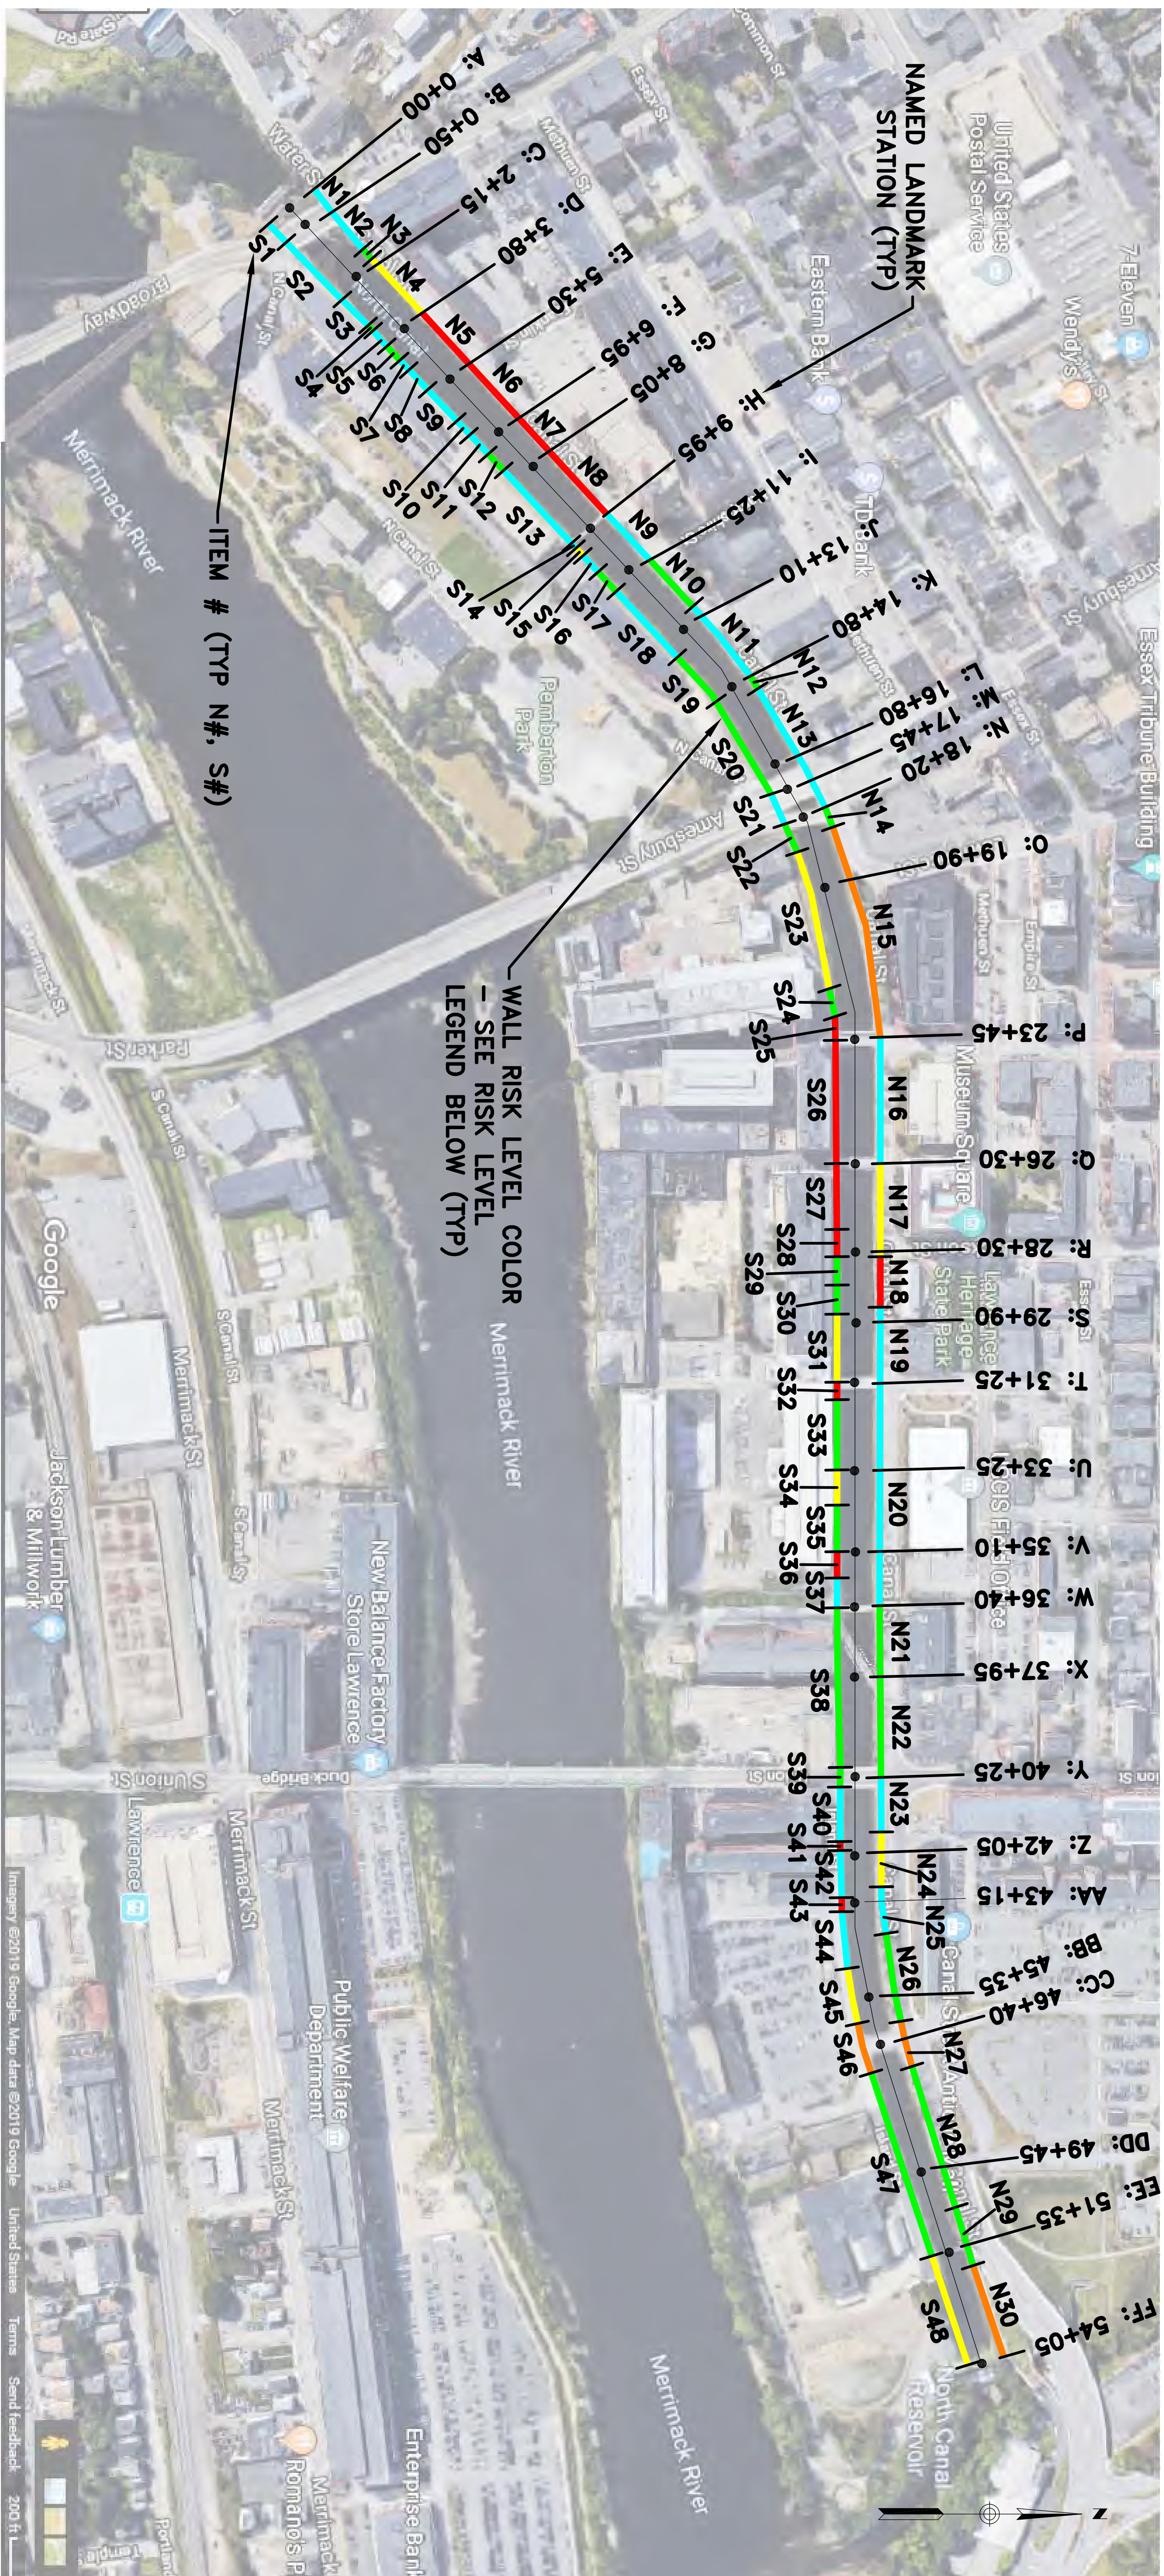
APPENDIX A: NORTH CANAL REFERENCE PLAN

- A : RAILROAD BRIDGE ADJACENT WEST OF BROADWAY
B : BROADWAY BRIDGE
C : DRIVEWAY BETWEEN TWO BRICK BUILDINGS
D : CENTER OF LORENZO BUILDING (AT DOOR)
E : FRANKLIN STREET
F : 90 DEGREE BEND IN CHAINLINK FENCE
G : EDGE OF BRICK BUILDING
H : PEDESTRIAN BRIDGE
I : HAMPSHIRE STREET
J : EDGE OF BRICK BUILDING
K : EDGE OF BRICK BUILDING
L : PEDESTRIAN BRIDGE WITH NO RAILINGS
M : AMESBURY STREET BRIDGE
